# USE OF THE HOMOPOLAR GENERATOR TO POWER XENON DISCHARGE TUBES AND SOME ASSOCIATED SWITCHING PROBLEMS

EP-RR 23

E. K. INALL

*March, 1969*

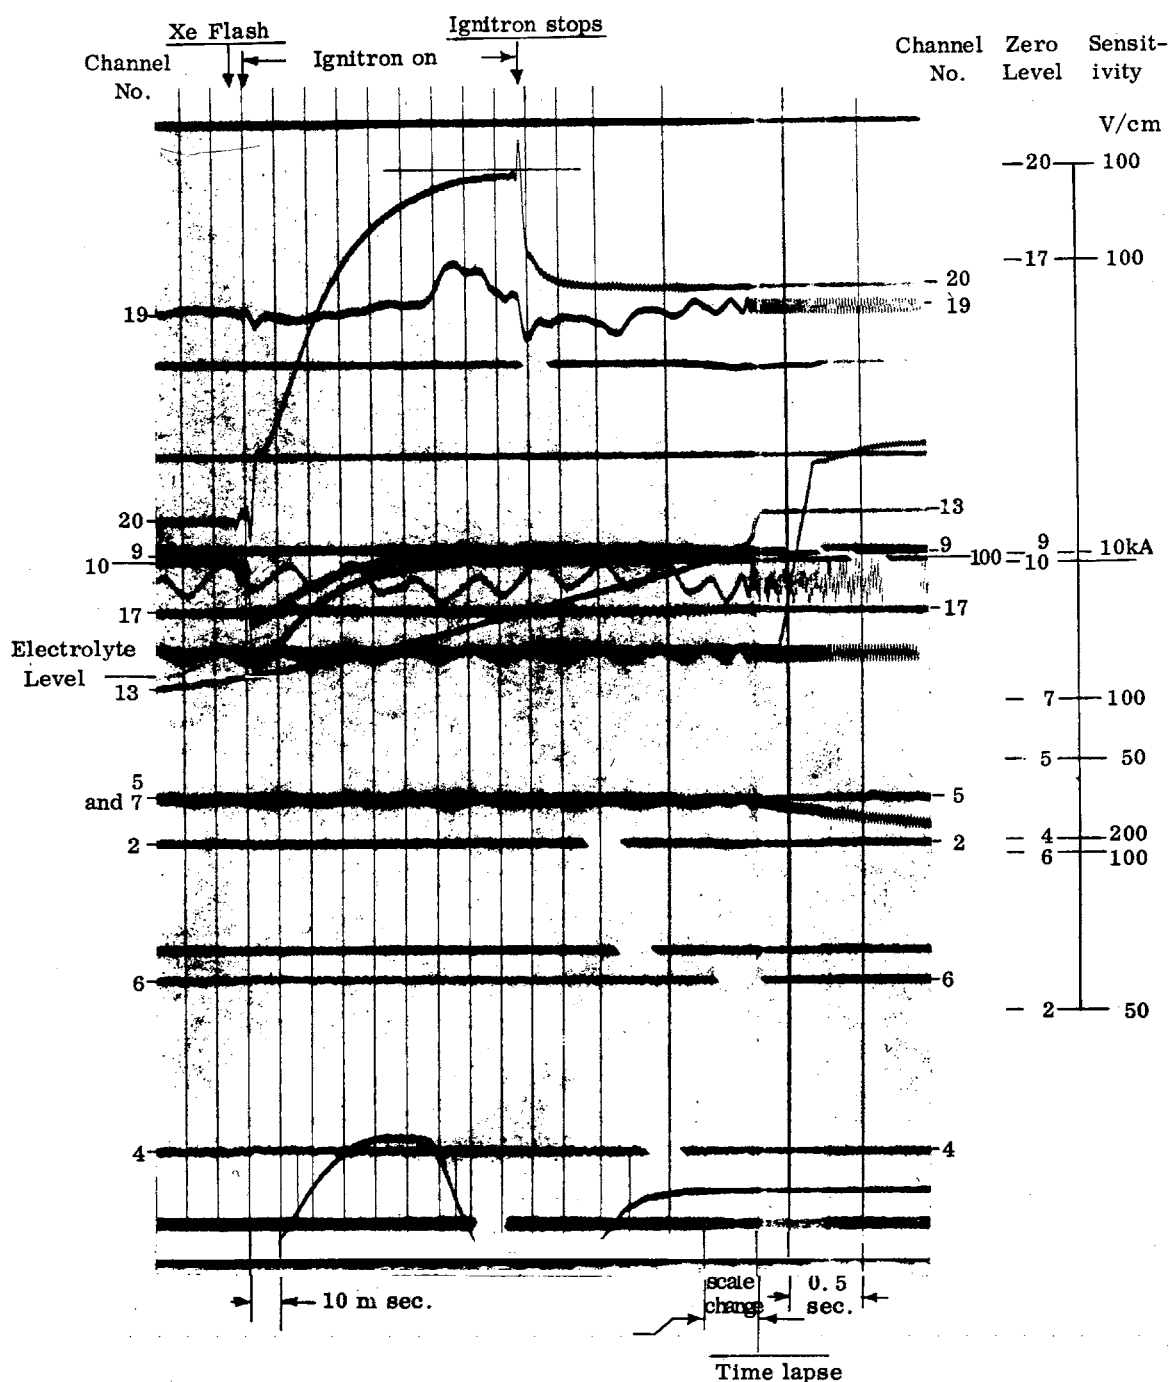
The current through RE did not drop to the value where the ignitron went out until about 90-100 msec after the electrodes would have left the undisturbed electrolyte surface. During this time the current decreased in a smooth fashion with a smooth decrease in  $di/dt$  until the ignitron extinguished at a current which could not be observed with the sensitivity used to record current ( Figure 2 ).

When the ignitron stopped conducting at the end of most pulses, the voltage across RE dropped to a low value, then settled to a figure determined by the leakage over the insulators of RE and the voltmeter resistance ( Figure 3 ). During some pulses, RE opened the circuit and the voltage across it did not drop to a low value

Figure 2 Reproduction of section of the recording galvanometer chart for pulse 16 on 27/11/68. This was typical of the pulses where the switch stopped conducting before the ignitron.

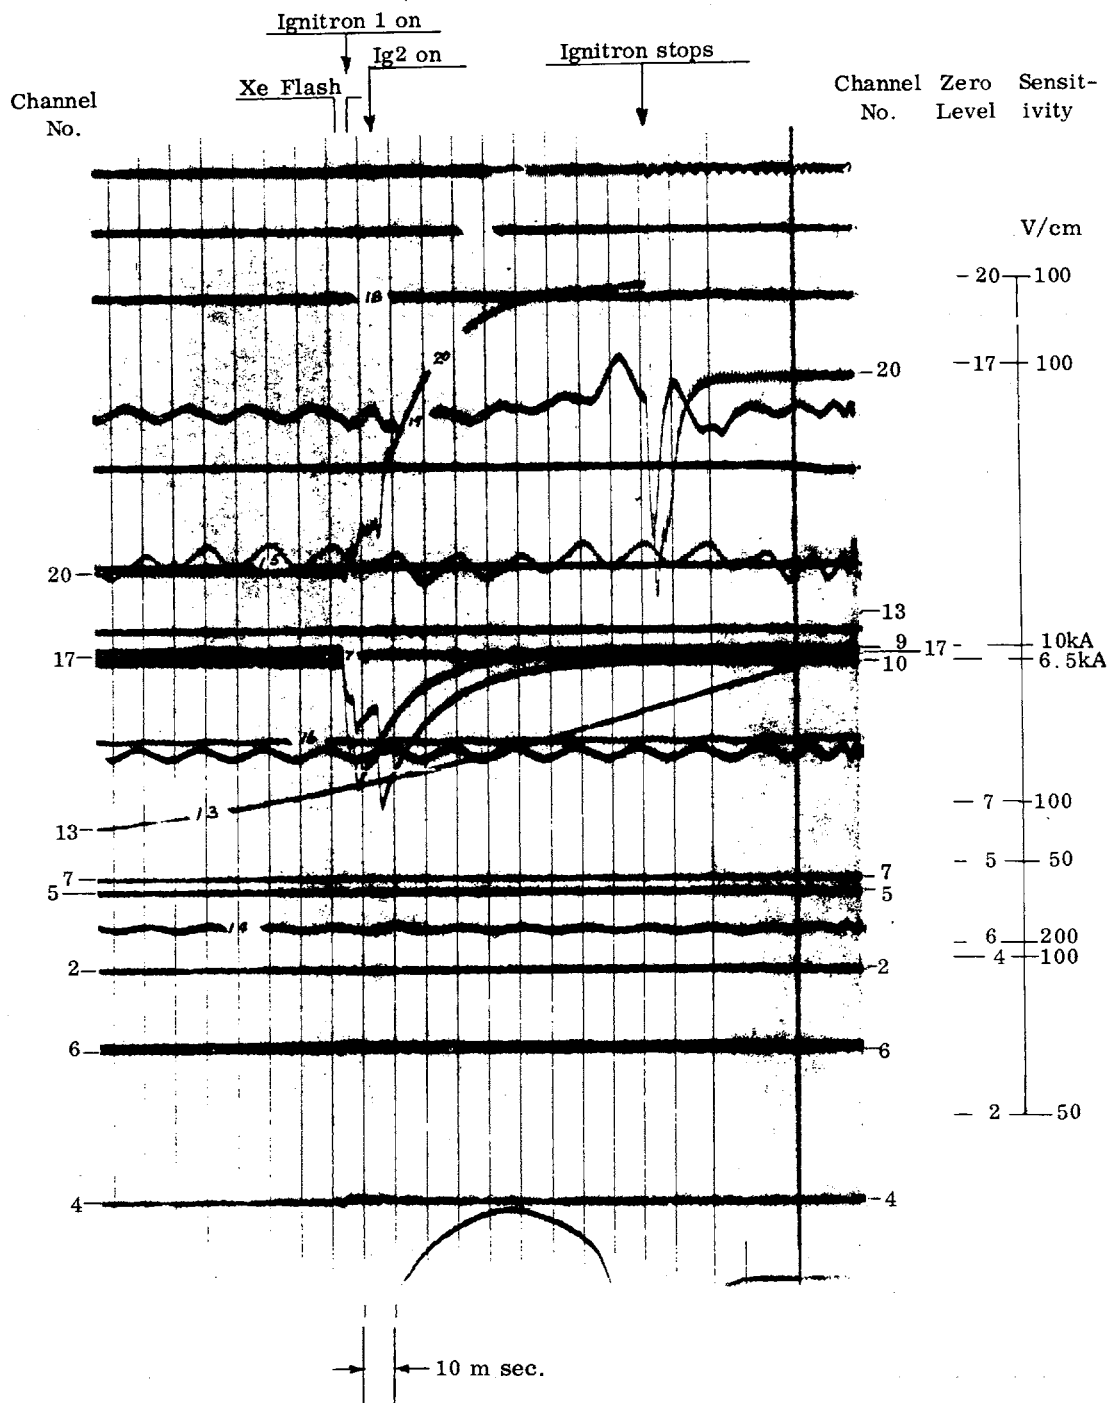
On 27th November, 14 pulses were run into a small flash tube and the current through RE was as expected (see Figure 3, which is the record of the pulse before the first flash-over in ES). During the 15th current pulse, (Record No.17, Figure 4), 20 msec after the ignitron was triggered, the current dropped rapidly due to a very rapid increase in the electrolytic resistance (RE) (see channel 19 which indicates the time rate of change of voltage across the electrolyte). The reduction of current was not due to the ignitron becoming a high resistance, since such changes reduce, not increase, the voltage across RE. The increase in voltage across RE was followed by an arc in it, which persisted for about 0.32 sec. and extinguished 1.7 sec. before the brushes of the generator were withdrawn from the rotors. The records show that valves, controlling the air pressure on the brushes, started to close 0.2 sec. after the current ceased.

Figure 3 Reproduction of part of the records for pulse 04 on 21/11/68. This was a typical pulse in which the ignitron stopped while the switch was still conducting.

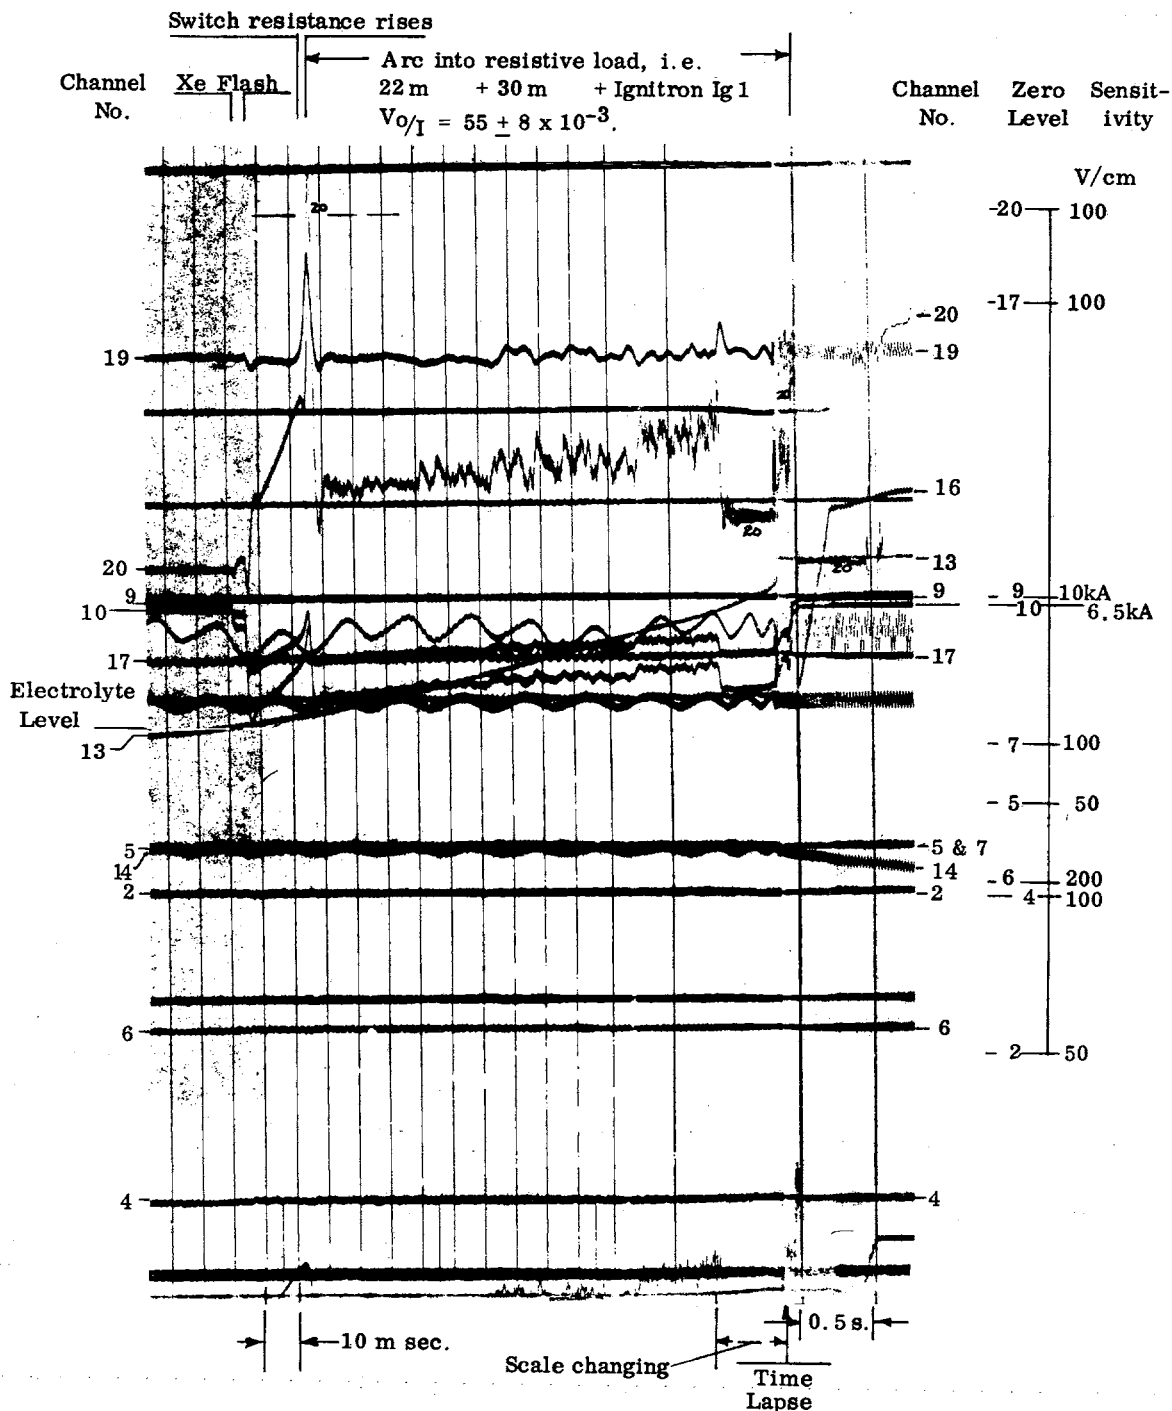
When the arc started in the electrolytic switch, the current to the load (made up of  $R_s = 22 \text{ m}\Omega$  in series with  $R_{ig} = 30 \text{ m}\Omega$  and the ignitron  $I_{g1}$ ), rose to 9,000 A. The voltage recorded shows the load resistance to be  $51 \pm 5 \text{ m}\Omega$ , showing that the ignitron and load circuit were intact. During the next 120 msec the current fluctuated in the usual manner for a current in such an arc, and the mean value fell constantly to about 6,000 A. The arc then changed, passing a higher and steadier current ( 9,000 A ), with a lower voltage drop, for 40 msec, while the load resistance remained about  $58 \pm 5 \text{ m}\Omega$ . The current then fluctuated and fell to

zero, but the voltage transmitted via the switch rose to the output voltage ( 600 V ) from the generator. When the resistors were examined later, both had melted at points where the current concentrated to give high current density regions. The melting resistors had apparently broken the circuit, (see Channel 19 of record) but the electrolytic switch still supplied enough current to maintain the voltage.

Figure 4 Records of pulse 17 on 27/11/68. This was the first time the switch resistance increased rapidly and an arc developed between the electrodes. The current stopped when the stainless steel resistors melted.

Because more than 140 pulses had been run without fault, but with the previous slow cycle of the electrolytic tank, there was some indication that waves caused by the faster operation of the tank may have started the arc. The rate of rise and the acceleration at the top were therefore reduced, and a smoother action achieved.

It was also decided that the bow switch would be set to open to end each pulse and that if an arc started again, the field of the generator would be turned off as rapidly as possible.

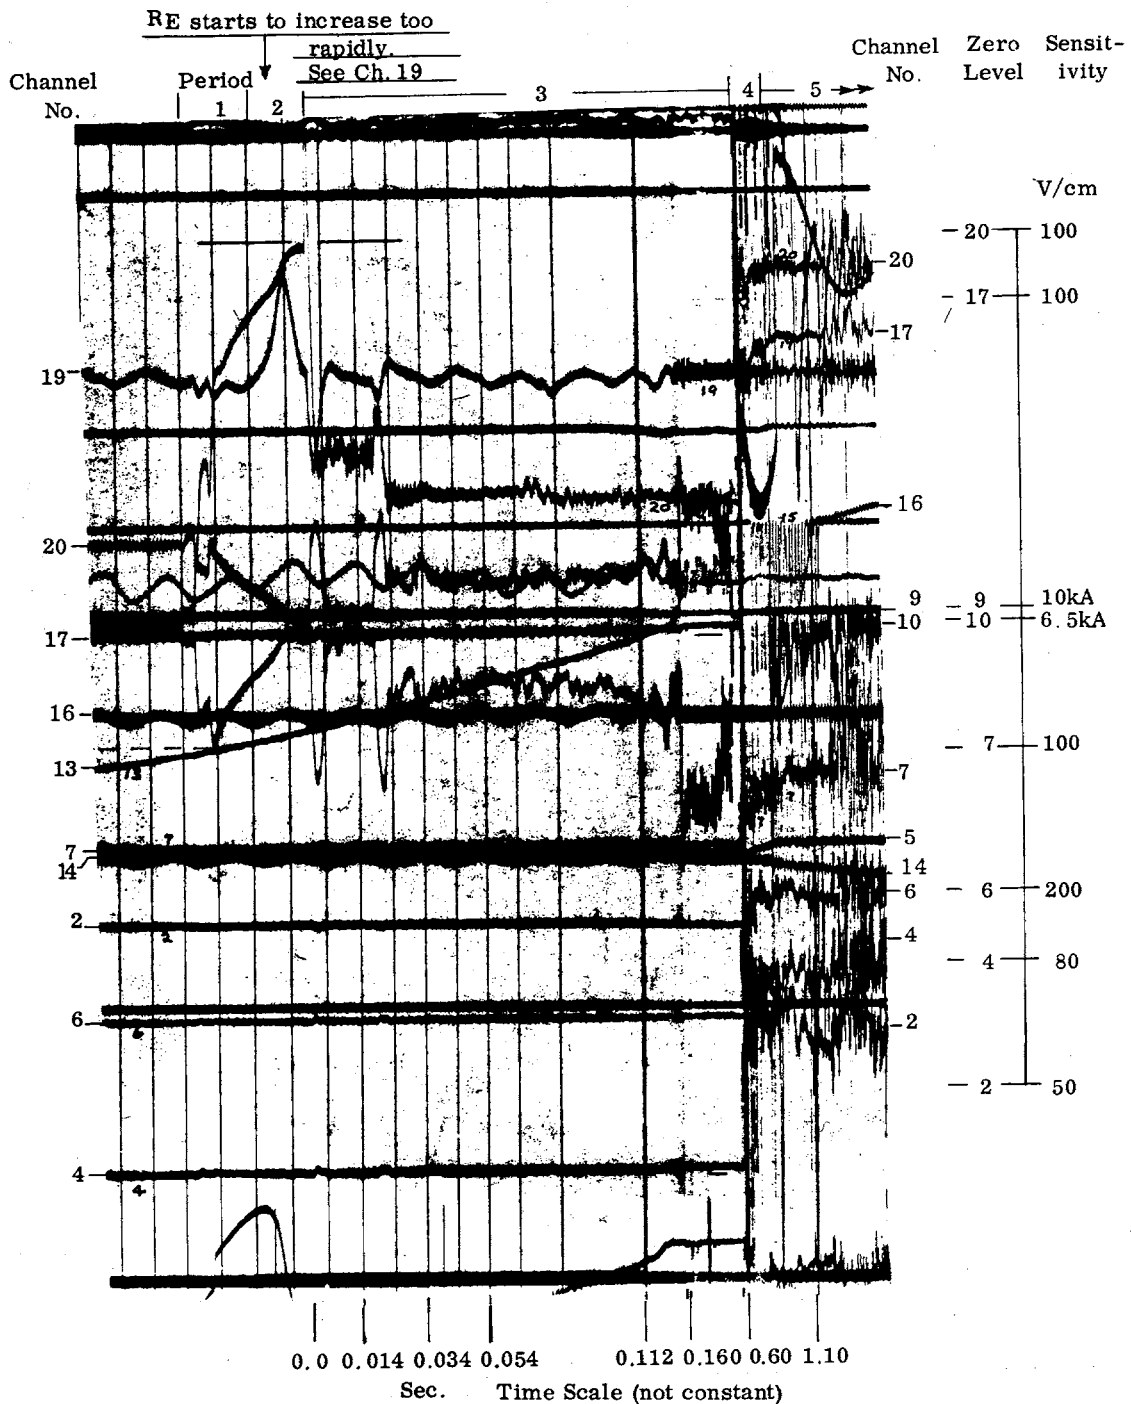
The sequence of events during pulse 05 on 28th November, 1968, can be divided into five consecutive time intervals (see Figure 5). We will look at these intervals in greater detail and consider some alternatives to the sequence of behaviour. The intervals are:

Figure 5 Records of pulse 05 on 28/11/68. An arc developed between the electrode of the switch and was followed by arcs in the busbars and generator.

- (1) The normal operation of the xenon tube, the two ignitrons and the electrolytic switch. A period of 0.020 sec.
- (2) An abnormal increase in the resistance of the electrolytic switch causing the current to decrease more rapidly than usual from 3,000 A to 500 A (see reference 2). The current remained at about 200 A for about 3 msec. The resistance of the electrolytic switch then rose to about one ohm. A period of 0.015 sec.

- (3) A sudden abnormal decrease in the resistance of the switch to a value of 8 m ohm for 4 msec. Thereafter the voltage across the switch remained about 100 V to 120 V and was independent of the current passing through it. A period of 0.50 sec.

- (5) The generator running on without magnetic field, with water supplied to the air bearings. The top rotor stopped within 40 sec., the lower rotor ran for 40 minutes.

In the case of the homopolar generator on the 28th November, an arc had developed in the electrolytic switch and from time 0.14 to 0.52 sec., Figure 5, a second arc was burning between the bus bars at the arc chamber end. During this period, a standing wave could have developed and decayed several times on the main bus bar system, and many of the small arc marks on the bus bar may have been made at this time. When the current dropped at time 0.52 sec., the arc in the test load was still conducting, and although the d.c. current was low, it could still be coupling radio-frequency power to the bus bars and generator terminals. The bus bars appear to have flashed over, either in the  $\frac{1}{2}$ " gap between the bars in the south-west riser, or the 1" gap where an arc had already been in the arc experiment cubicle. This arc caused the damage to the homopolar generator.

Returning to the period from time 0.52 sec. to 0.58 sec., trace 9 of Figure 5 shows no current was flowing via the electrolytic switch to the arc enclosure, and trace 10 indicates about 300 A flowed through the bus bars. Such a current could flow only through some leakage path in the bus bars. It is suggested that it was via ionised air initially produced between the bus bars on the south-west riser, by high radiofrequency voltages generated between time 0.14 sec. and 0.52 sec. The 300 A current apparently maintained a steady ionization until the cathode areas became hot enough to change to an arc mode. If this occurred at time 0.58 A, the current could have risen to several hundred thousand amperes and caused the initial damage to the sliding brushes. The amount of aluminium burnt from the south-west riser indicates

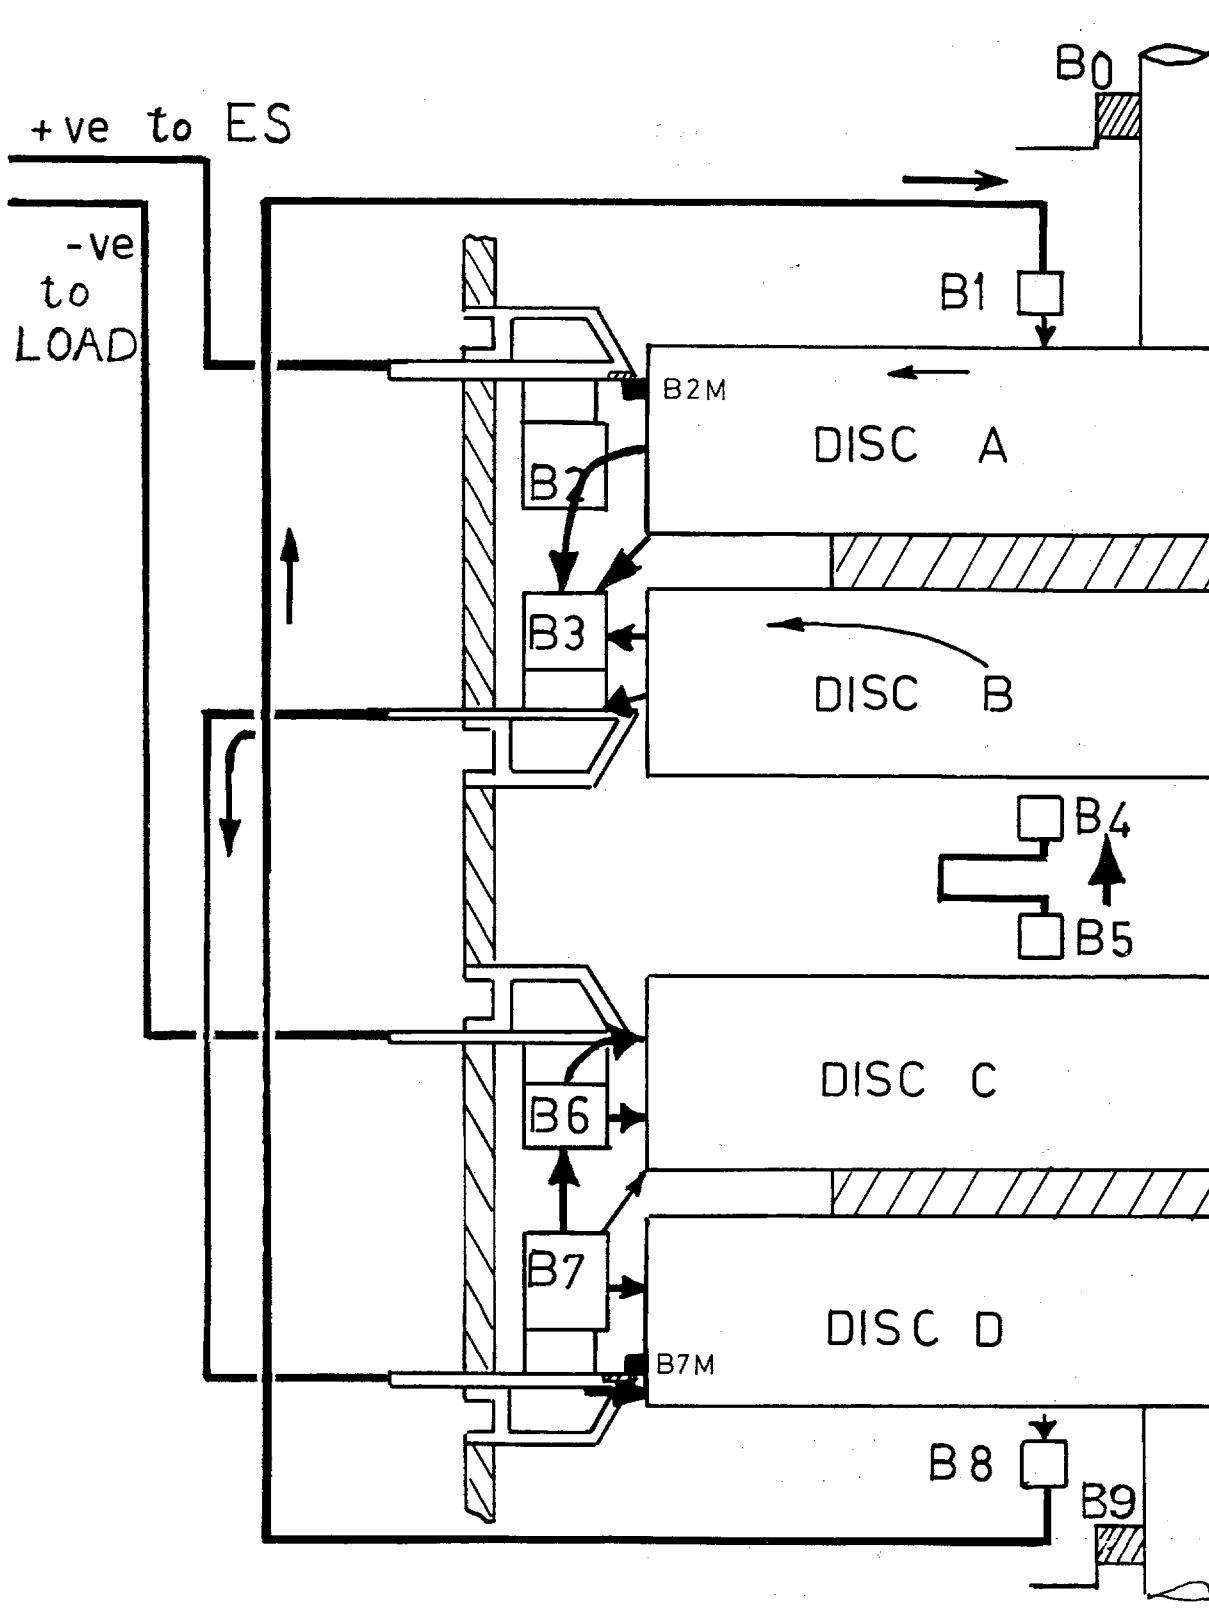
Diagram of brush and rotor identification. The circuits in which the fault currents could flow are shown by the arrows.

disconnected from it on the 28th November, could have arced over due to a voltage surge coupled to them from the common input to the ES. Such an arc would be a very low impedance load on the generator, drawing current without it having to pass through ES. The current could rise rapidly to a value sufficient to twist the sliding brushes and the twelve outer brushes being used, so that they would have broken away from their supports.

The rupture of the active brushes then could have led to the formation of arcs carrying several million amperes within the generator, slowing the rotors by at least 220 r.p.m. in 0.2 sec. By time 1.2 sec., that is, 0.6 seconds after these arcs started, the speed of the upper rotor was  $330 \pm 20$  r.p.m. and the lower one  $300 \pm 20$  r.p.m.

Secondly, the circuit from B3 to B7 and then to B6 or the edge of disc C via arcs, through disc C and brushes B5 to B4, until they were replaced by an arc, then via disc B to complete the circuit at B3. Both discs B and C were generating 130 volts and the current could have been nearly as large as in the first circuit, the difference being due to the voltage across the arc which took over from B4 and B5. These two circuits are similar and could occur in parallel. This is implied by the voltages listed above at time 0.61 sec. Since brushes 4 and 5 were structurally the weakest, an over-current would have caused this unit to break first. It would have been replaced immediately by an arc developing from parts of the structure contacting the rotor and the current would have continued to increase into the external circuit until units in the outer rings failed and arced to the adjoining discs or brushes.

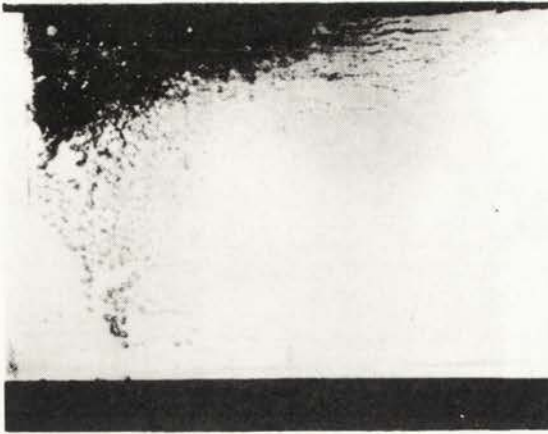
Open end.

Initiation of arcs  
in S.W. bus bars.

Figure 6      Showing how arcs developed from some initiating discharges but not from others.

The bus bars were insulated to work at 1,000 V d.c. They had previously been tested to 2 kV over some of their length and 1 kV on other sections. A test voltage of 800 V was applied while the generator was being run up in the four disc mode. Tests on the insulators show that the bus bars would break down at about 10,000 V d.c. due to tracking across the surface of the bakelite spacers in the corner clamps, and 12-13,000 V d.c. across the surface of the  $\frac{1}{2}$ " spacers on the vertical runs. However, it is well known (see Terman<sup>(5)</sup>, page 123) that the dielectric strength of air is somewhat less at radio-frequencies than for d.c. and low frequencies. It is also well known that pulse voltages lasting a micro-second or less do not cause break-down across surfaces, in dielectrics, or in gases, at values well in excess of the steady value that would cause such breakdown<sup>(7)</sup>. It is very likely that a peak voltage of 3,000 volts at one MHz on top of 500 volts d.c. would cause the  $\frac{1}{2}$ " air gap in the vertical bus bars to arc over, while a 10,000 volt pulse lasting one micro-second, on top of the steady 500 volts would not cause break-down. There seemed to be evidence that break-down due to radio-frequency voltage had occurred. The appearance was confirmed by an experienced welder (Mr. W. O'Neill) when he commented without being asked, that the marks left by the arcs in the south-west bars were similar to those produced by the argon arc welder when the "Pilot-Arc" was used to start it, and the welding arc was swept across the surface of the aluminium. The marks show that many hundreds of small discharges occurred, some, but not all of which led to heavy d.c. arcs (see Figure 6).

A further precaution against transients and voltage build-up, which must be observed in future, is to never leave a length of unused bus bar connected to the generator terminals.

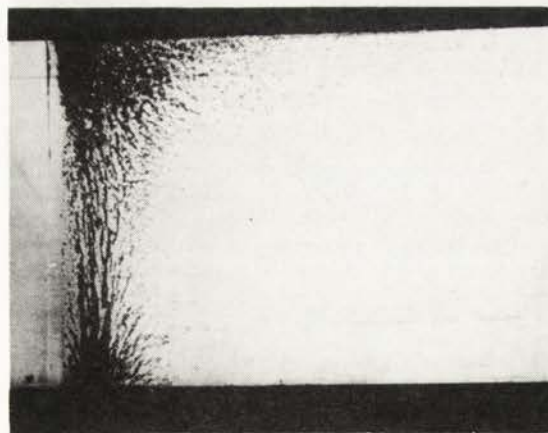
Upper clamp  
below clamp  
at which most  
powerful arc  
occurred.

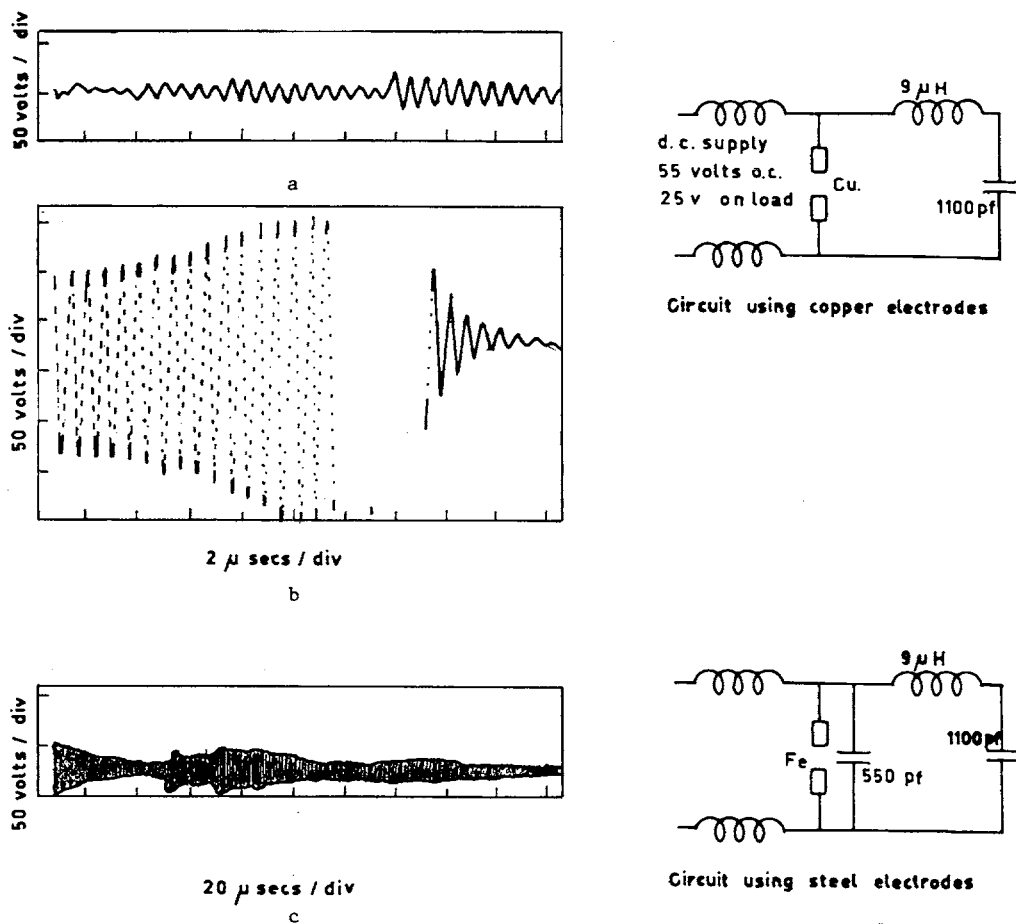
Figure 8 Tracings of oscillograms showing changes in the amplitude of 1.5 MHz oscillations in a resonant circuit. The voltage measured across the capacitor shows:

- (a) Increases occurring as a series of in-phase transients.
- (b) An example of a continuous increase to a large amplitude, followed by sudden quenching.
- (c) The fluctuations of amplitude over a period of 200  $\mu$  sec.

(a) and (b) were recorded while using copper electrodes, and (c) using steel electrodes.

The highest excitation of the circuit was transitory but values as high as 200 volts peak amplitude across the condenser were observed (see Figure 8b which shows a record of a case when the voltage was greater than 150 V peak). The decay of amplitude was at most as great as that due to the losses in  $L$  and  $C$  and on occasions less, indicating that the resistance of the arc was very low and in some cases negative, at a frequency of 1.5 MHz. The oscillations recorded in Figure 9 occurred repeatedly when the electrodes were set to produce drops of molten steel which fell across the arc gap. In this case, a momentary interruption of the current through the arc could cause  $C$  to charge to a high value due to the voltage developed across the chokes  $L_1$  and  $L_2$ . If the arc then became a very low resistance, the circuit would have continued to ring with a decay due to the losses in  $L$  and  $C$ . If the arc was in a transient state in which it could present a negative resistance, the oscillation could increase in amplitude as some records show (see Figure 8).

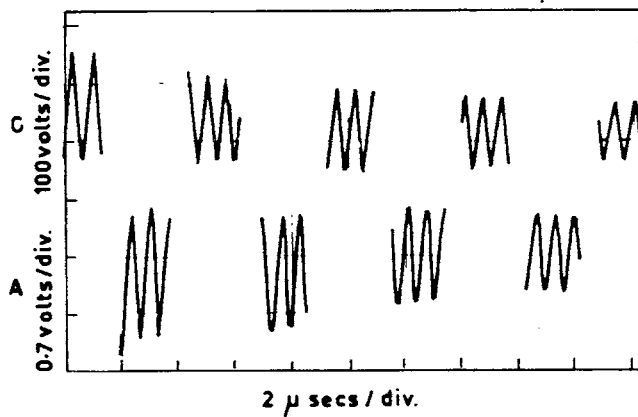
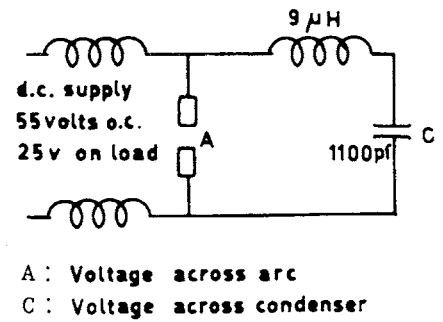
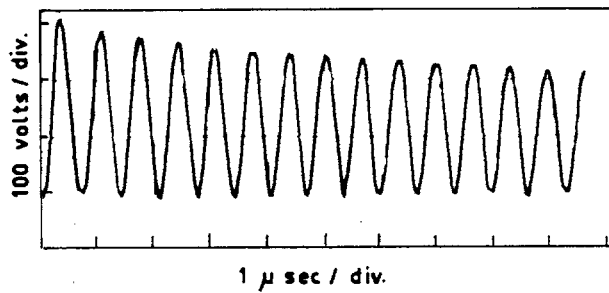
Figure 9 (a) The radio-frequency voltage across the arc, A, observed alternately with the voltage across the capacitor C.

(b) The typical decay of a transient oscillation in the resonant circuit including the arc.

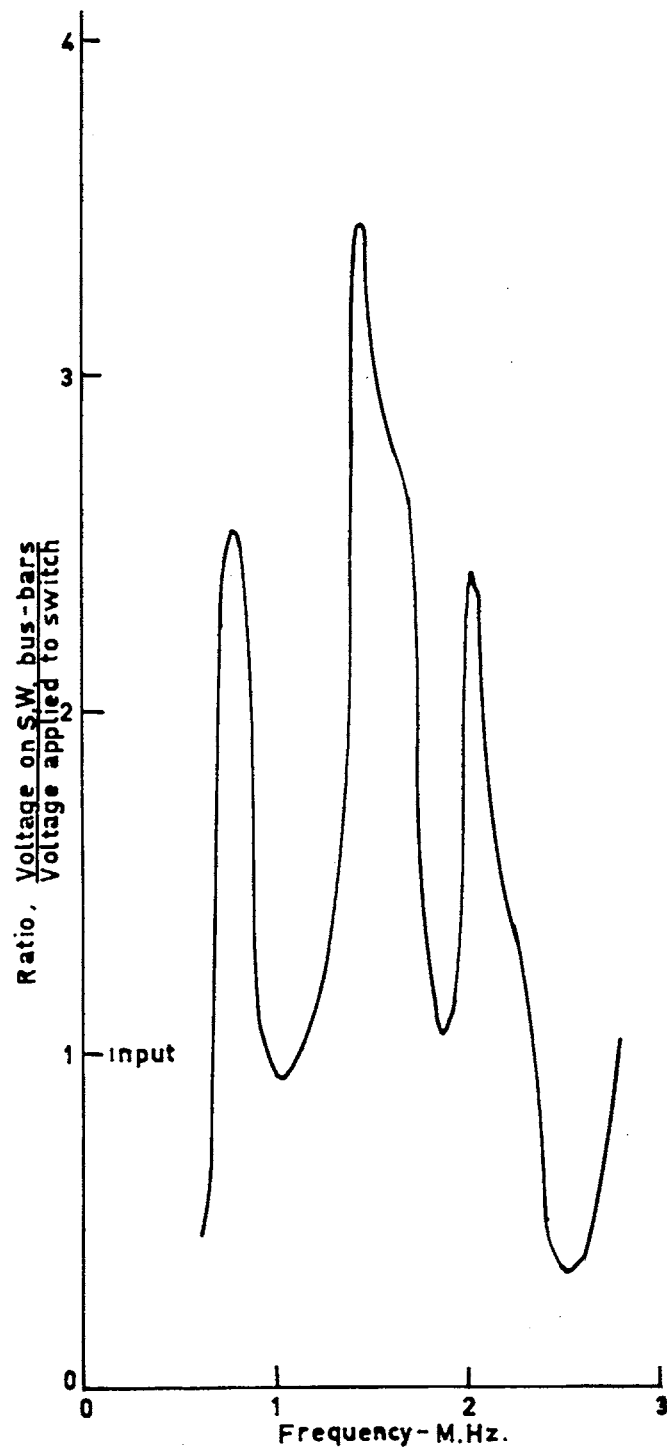
Three resonances with antinodes at the south-west end were observed in the frequency range 0.6 MHz to 2.8 MHz. The dominant one was at 1.5 MHz where a 3.6 fold increase in voltage was observed. The normalised readings over the frequency range are shown in Figure 11. For each of these resonant frequencies, the 14 M length of open bus bars from the switch was less than a quarter wave length long, and therefore was equivalent to a capacitor coupling into a line about 52 M long, open at one end and shorted at the generator end. Frequencies at which the impedance looking into the feed point was inductive and which resonated with the loaded line, gave rise to standing waves with high voltages at the open end. The measurements show the frequencies at which such resonances do occur.

Figure 11 Three resonances of the bus bar system with an open circuit at the arc enclosure end.

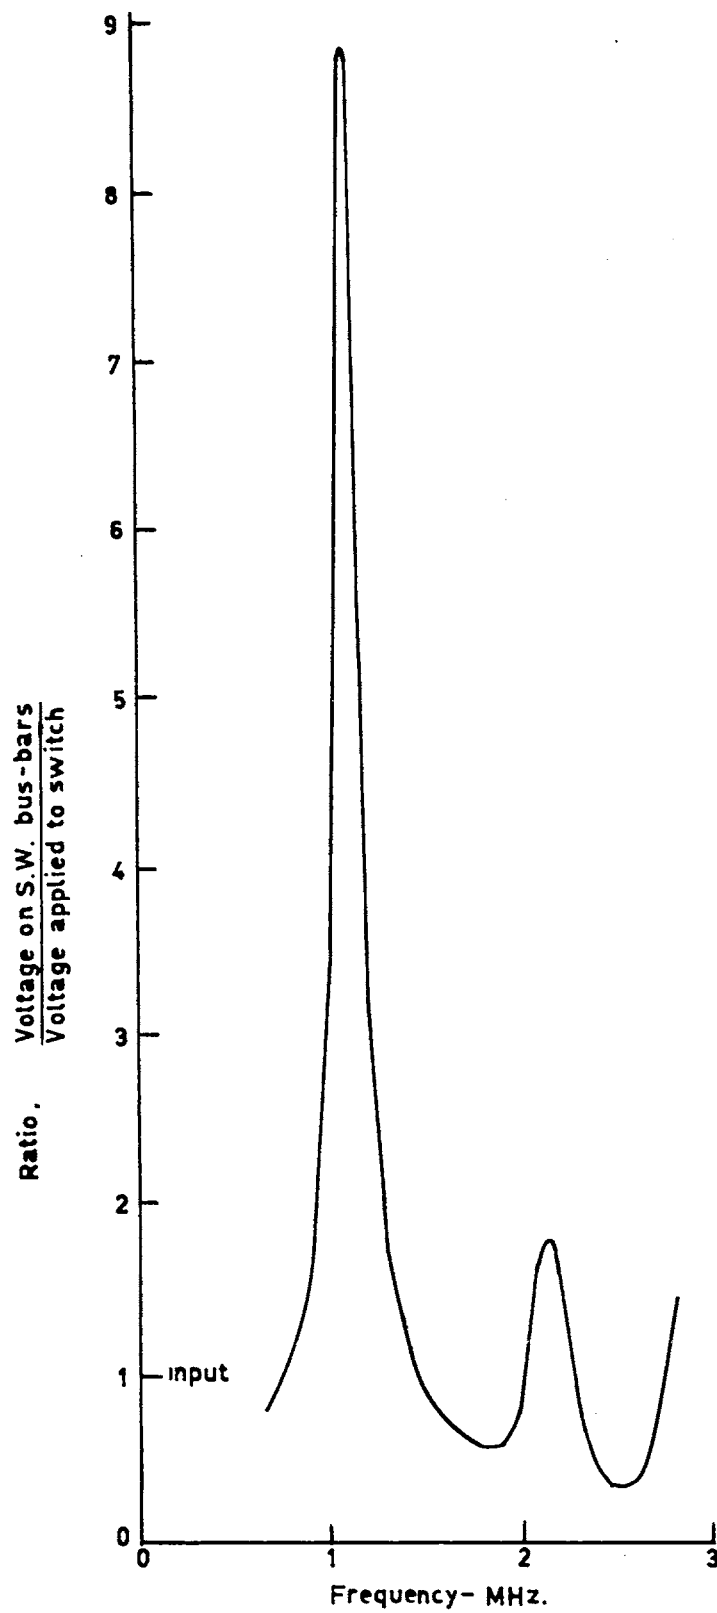
Other sharper and more discrete resonances occurred when the bus bars were shorted at the arc chamber end. In this case the dominant mode was a frequency of 1 MHz; at this frequency the voltage at the open end was 8.8 times that applied to the electrodes (the normalised measurements are plotted in Figure 12). When the short circuit was replaced by a non-inductive resistance of 0.5 ohm the resonance at 1 MHz was heavily damped, as shown in Figure 13, while a termination of 2.5 ohms, was too high to match the characteristic impedance - see Figure 14. The peak in the response at 2.1 MHz was present in all measurements and was due to

Figure 12 The dominant resonance at 1.1 MHz which occurs on the bus bar system when shorted at the arc enclosure end.

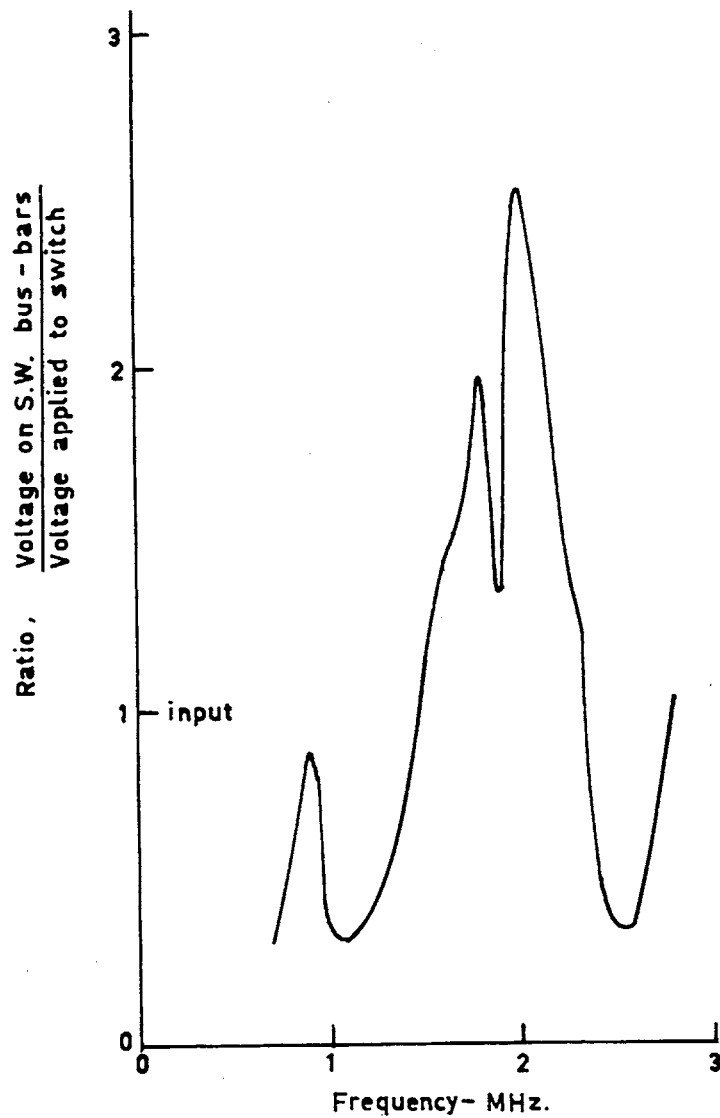
Figure 13 Resonances observed when the bus bars to arc enclosure were terminated with 0.5 ohms. This resonance is associated with the electrolytic switch electrodes. The main bus bar standing wave has been damped out.

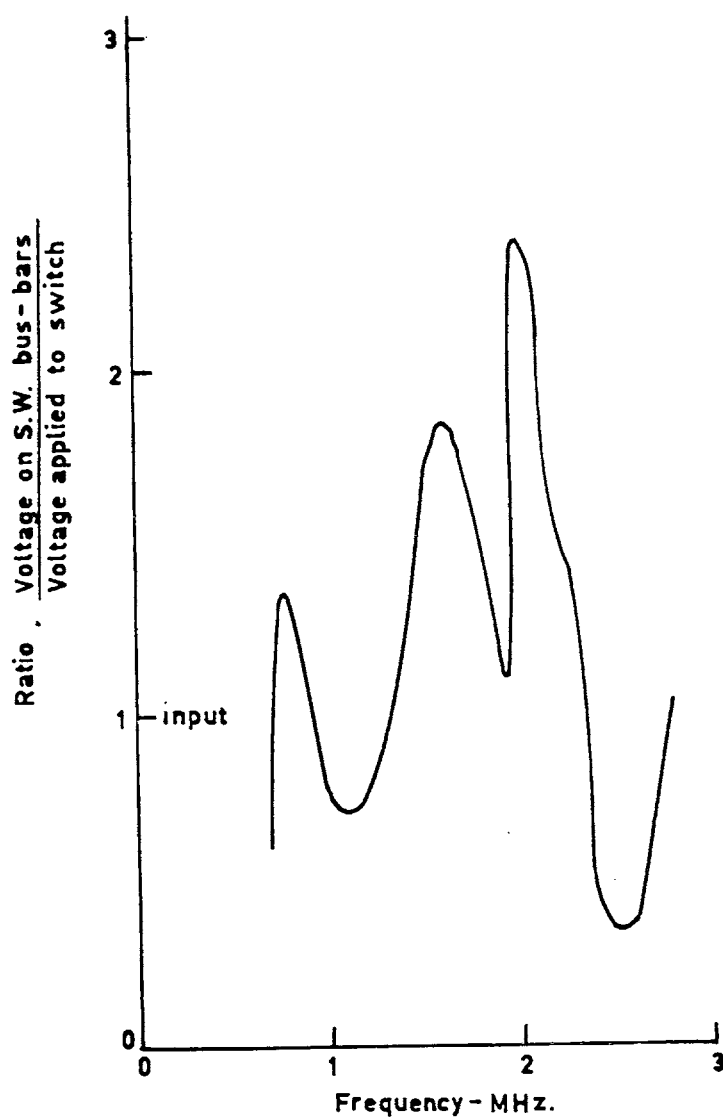
Figure 14 Resonances observed when the bus bars to the arc enclosure were terminated with 2.5 ohms. In this case the open circuit standing wave pattern with a maximum voltage at 1.5 MHz is not completely damped.
