ASSEMBLY NOTES
MACHINE NO 2

MONTPELLIER

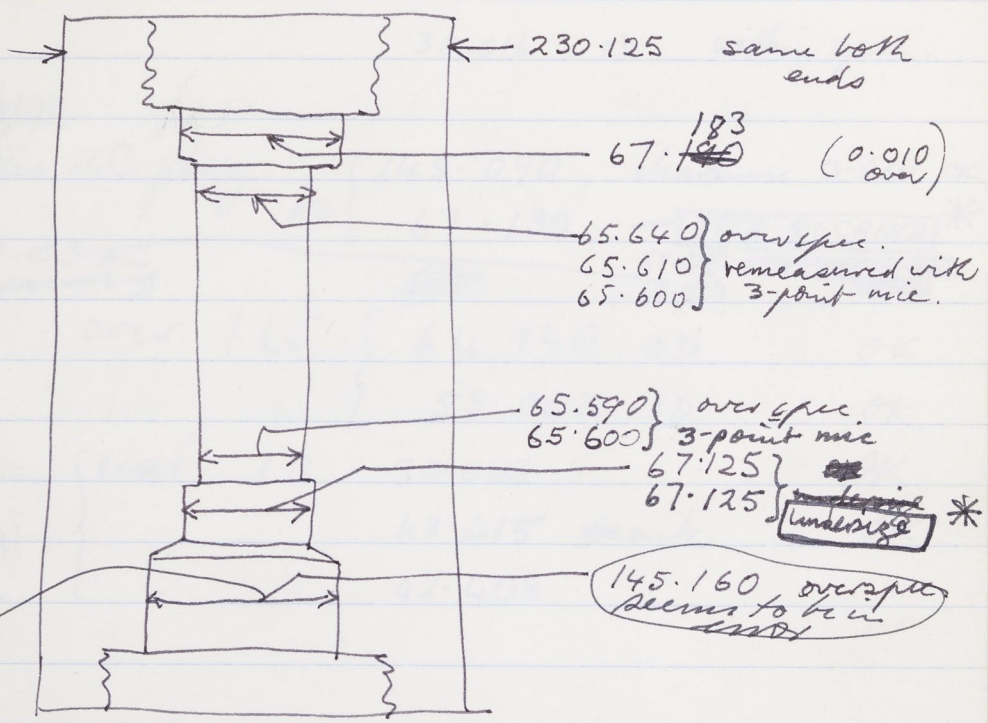
Pressure Vessel dimensions after re-grind:

Vessel threads been chased (a bit of chatter)
 Top nut goes in OK: been semi-blacked
 Bottom nut " " "
 Inner top nut fits OK.

Not been remachined on bottom face * — done by Frank 24/1/91

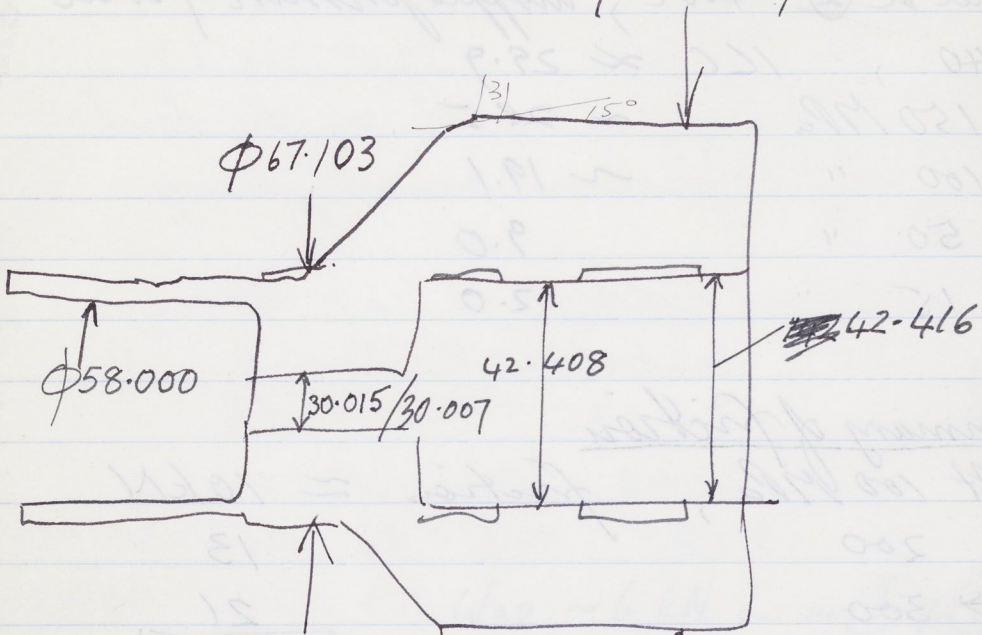
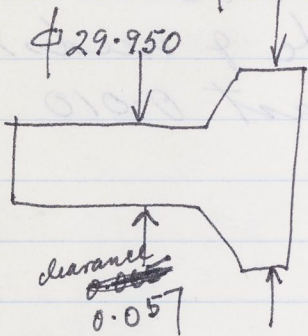
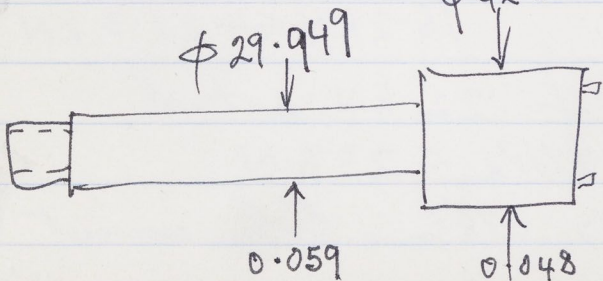
Dismantled bottom plug

Plug does not go right in — short by ~2mm. Appears that the R3 on the pressure vessel is too large, so a 15° x 3 mm taper was machined on the OD of the plug ~~4103~~ 4101 at the edge of the 45° taper.

The $\phi 58$ guide surface for the ILC piston is strongly marked as if it were a bit tight, but it is hard to imagine that this could generate 25kN of friction. However, it does appear, from extrusion of the O-ring, that the ILC is not seating properly & therefore there will be compressive force on the threads under pressure, tending to increase the OD. Relieved ILC support (4103 (12)) so that ILC seats properly. Re-assembled.

reduced this diam to $\phi 145.070$ to overcome difficulty of getting nut right in

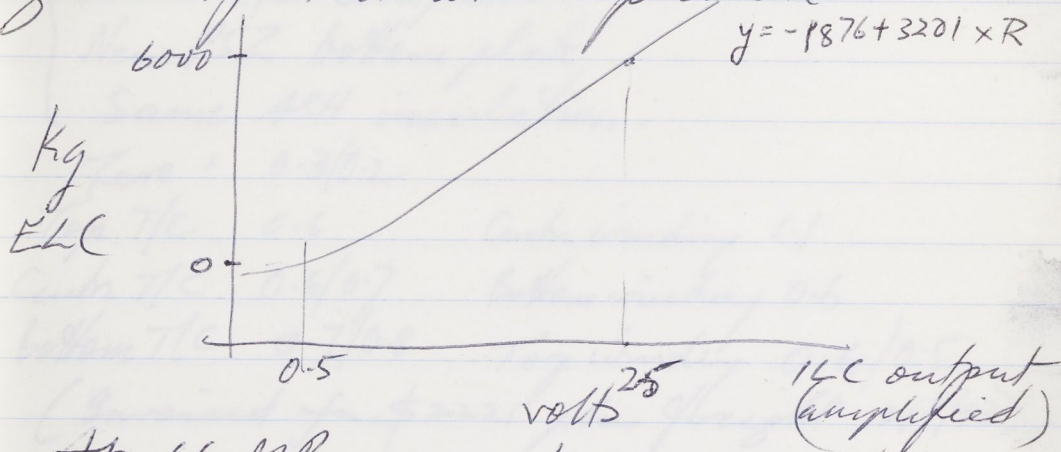
At 66 MPa, zero has moved to $-2.6V$ (ie equiv to $-60 kN$). Previously it moved to $\sim +6V$ or thereabouts (about same load but opposite).

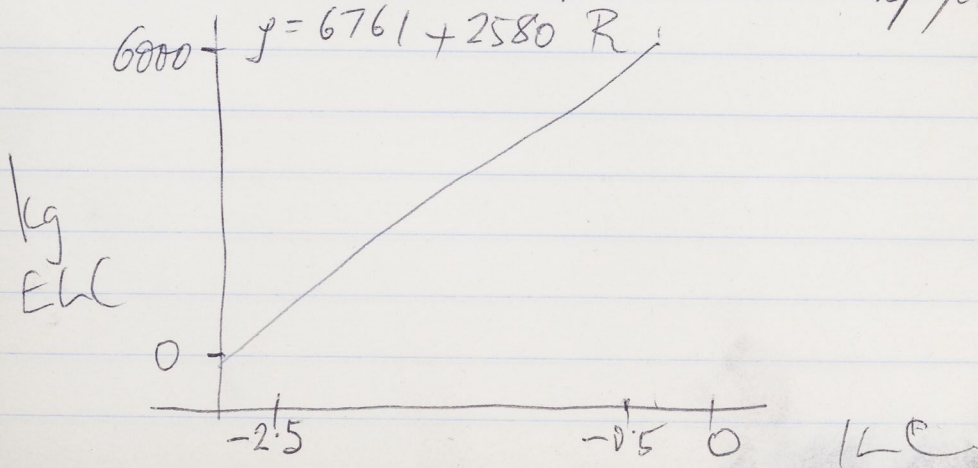
Some hiccup at $\approx 0.6V$ (maybe wires)
Plot gives increased sensitivity at higher
pressure (unless this is due to friction?)
