# ASSEMBLY NOTES MACHINE NO 3

MINNEAPOLIS

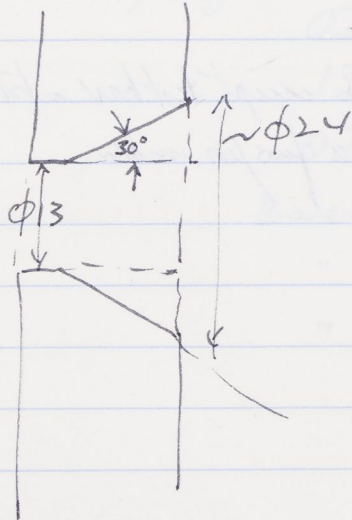
In the course of changing the panel arrang<sup>ts</sup> in the housing, it turned out that the valve stem extensions would interfere with the 12mm inner panel owing to the hole now being 13 $\phi$  instead of the large hole in the inner 5mm panel in No. 1 & 2 machines. This can be fixed by tapering the valve stem extensions

~~tap~~ chamfering the hole as shown. We now have 8mm of travel of the valve stem, more than enough, and there is still substantial

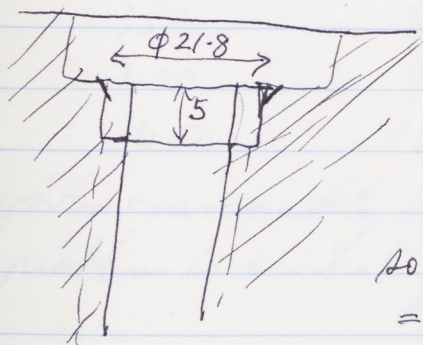
Then found that the stirrup was not screwing right up to shoulder on the piston - the thread had not been cut to the end. So had to relieve the thread for 5 mm,

leaving about 15 mm of thread.

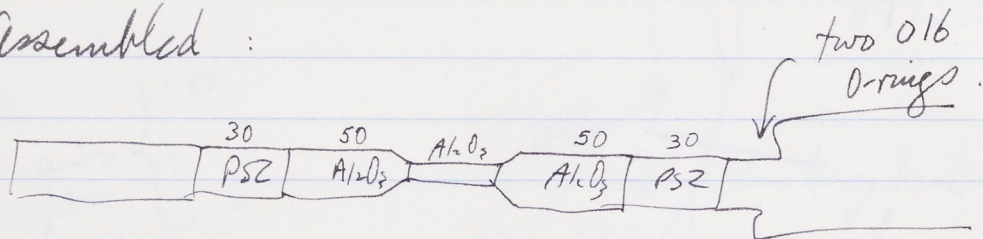
(T/C would not go through 85  $\text{Al}_2\text{O}_3$  pistons  
— hole off centre > clearance).

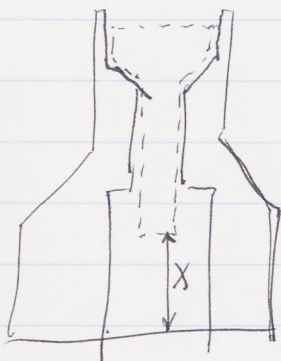
According to drawings, dimension X should be 61. In actual measurement, it was 63.4 or 63 (~). The  $\phi 30$  part of the piston seemed to be about 64.5 instead of 65. Thus around 0.5 of the excess may have been on the piston and nearly 2 in the body of the plug. Thus we need a spacer of 2.5, with OD  $42.3_{\text{max}}$  and ID  $30.1_{\text{min}}$  to prevent the fracture of the connecting rod that has already occurred.  $\rightarrow$  Another measurement showed a gap of ~~2.2~~ 2.2, so 2.5 should be OK.

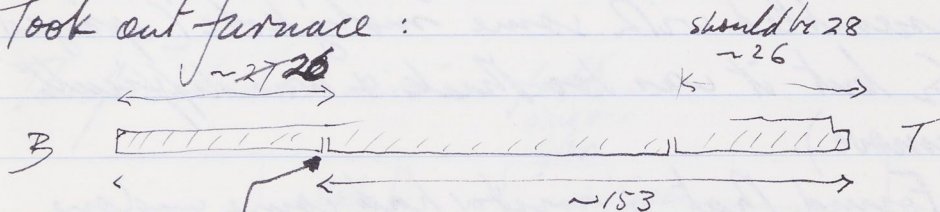
When we had the furnace out, there seemed to be a join in the core at about 8 mm above the bottom end of the inner sleeve — but there shouldn't be such a join according to the drawing. Is there a crack here?

Has handling the furnace shaken the zirconia loose insulation around? It was tipped up & down many times. There is also a break in the Macro bottom piece, at the lip below the core.

Inserted 50 mm length of iron liner in bottom end to cover the gap (couldn't tell whether it was an intentional join or not, but it seems to be exactly at the bottom end of the bottom winding)

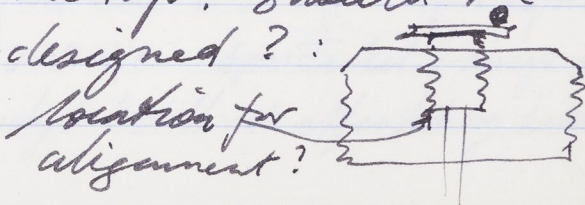
Discussed problems of misalignment — question of squareness & rigidity of the small screw at the top. Should the top plug be re-designed? :

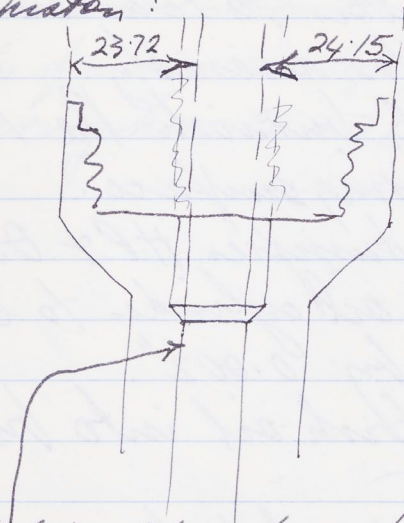
Piston now would not screw on to load cell.

across at approx  
azimuth of flats

$$\begin{array}{r} 24.15 \\ 23.72 \\ \hline 0.43 \\ 0.215 \\ \text{off centre} \end{array}$$

Possibly  $\text{MoS}_2$  burnish the ILC  
piston bearing surface.
