Deformation and Failure Behaviour of Self-reinforced Polypropylene and Self-reinforced Polypropylene/steel Fibre Metal Laminate

Jae Young Nam

A thesis submitted for the degree of Doctor of Philosophy of The Australian National University.

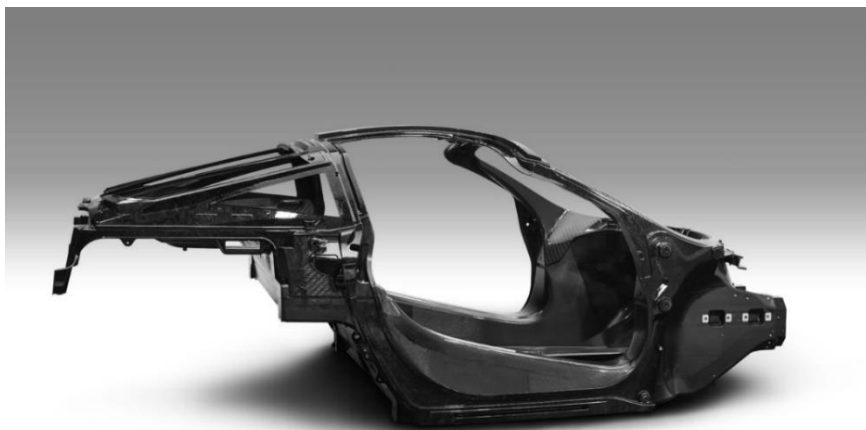
Figure 1.2 Carbon fibre-reinforced composite component in the body of McLaren 720S. [8]

A question may arise, at this point, regarding other materials that could replace some of the steel parts in automotive vehicles. Indeed, there is a clear appetite in the automotive industry to use materials such as aluminium and composites. (See Figure 1.2 for an example.) These materials are used mainly for reducing vehicle weight and, in some cases, for additional improvements in other properties. However, this has brought to light several challenges, such as the lower formability of aluminium alloy compared to steel, and composites requiring processing (e.g. manual hand layup) that are not suitable for existing mass manufacturing techniques. Also, composites require significant modifications to joining and surface painting techniques traditionally utilised for steel parts. While this is not a major barrier for luxury car manufacturers with relatively small production volumes, it poses a considerable challenge for companies that are reliant on mass production with high rates of output and lower unit production costs. As such, steel remains the primary material used in the automotive industry, as exemplified by the extensive use of steel in the body of the Volvo XC90 (Figure 1.3).

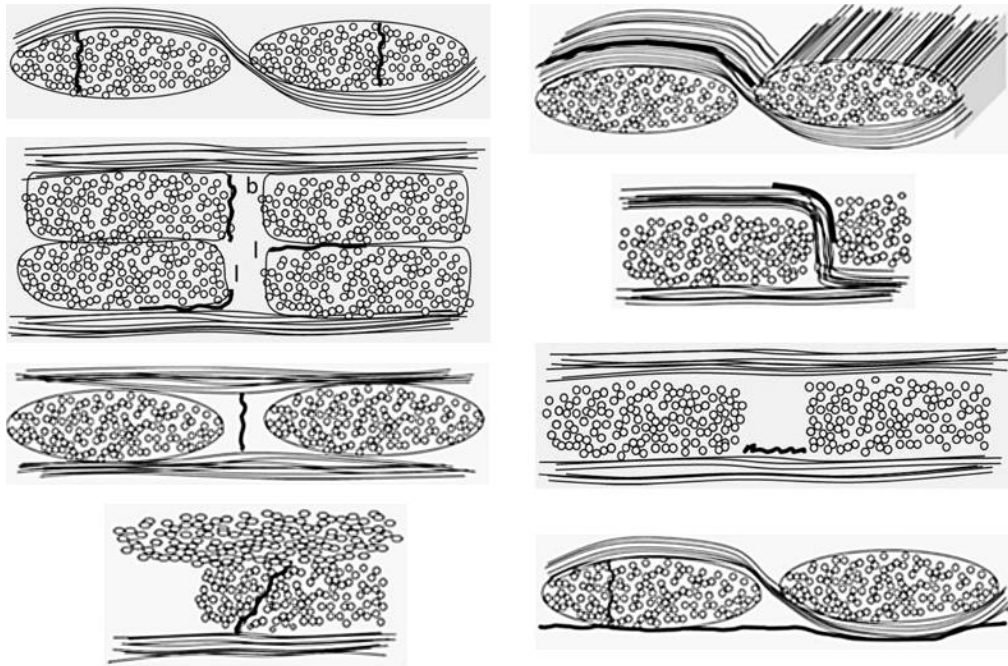
Figure 2.4 Different types of cracks observed in textile composites loaded in tension. From top to bottom in left column: transverse matrix cracks inside yarns, transverse cracks at yarn boundaries (b), debonding of yarns and local delaminations inside yarns (I), transverse cracks in the matrix pockets, shear matrix cracks. From top to bottom in right column: splitting of the yarns, cracks on the boundary of or inside Z-yarns, longitudinal cracks in the matrix pockets, delaminations. Taken and modified from [24, pp. 43–44, Tab. 3.1].

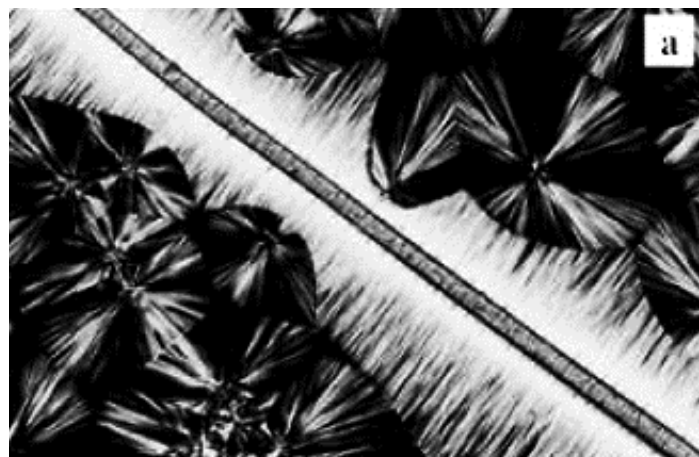
Figure 2.9 Polarised optical microscopy of the fibre-matrix interface of an SRPP formed by introducing fibre into a molten matrix at 167°C [121, Fig. 2a].

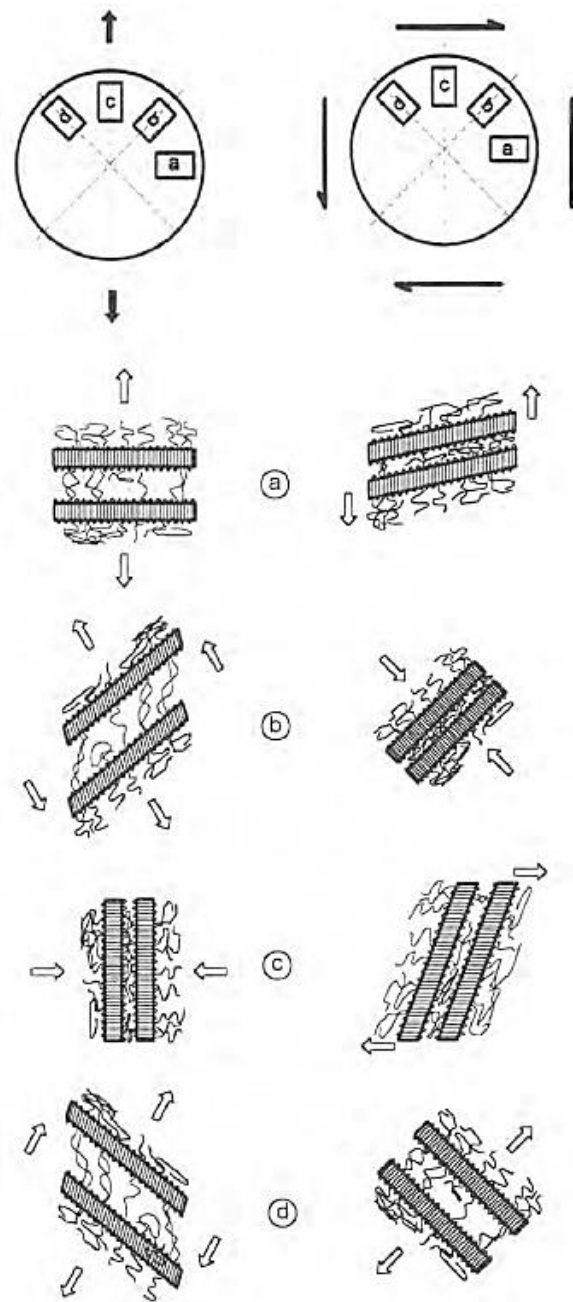
Figure 2.14 Behaviour of the different sectors in PP spherulites under uniaxial tension and simple shear [133, Fig. 13]. The black arrows represent the applied stresses and the white arrows the locally active deformation mode.

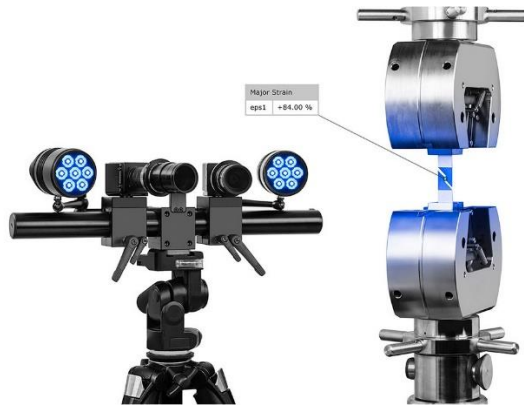
Figure 3.13 ARAMIS, a commercial digital image correlation system provided by GOM GmbH [218].

To capture and analyse deformation characteristics leading up to a catastrophic failure of the material, a state-of-the-art DIC system called ARAMIS 5M [218], shown in Figure 3.13, was used. This system tracks real-time strains on specimen surfaces as they deform, using digital cameras that take high-resolution images at high speed. Based on a stochastic pattern that is inlaid on the surface during specimen preparation, it creates and tracks virtual gauge areas composed of an assigned number of pixels called facets (shown in Figure 3.14) and computes full-field strains by DIC. In this research, the resolution in the field of view was 2448×2050 pixels and the rates were set at 5–15 frames per second, using ARAMIS 5M.

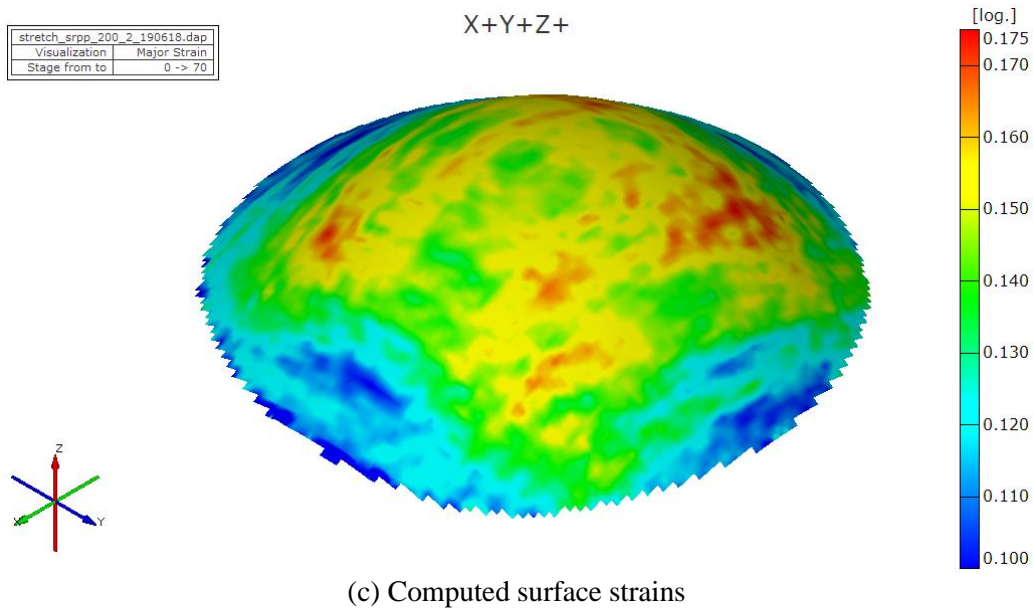
Figure 3.17 Examples of DIC images for a deformed circular SRPP specimen, showing a) a digital image from the left camera, b) strain grids superimposed on a digital image from the right camera, and c) computed surface strains.

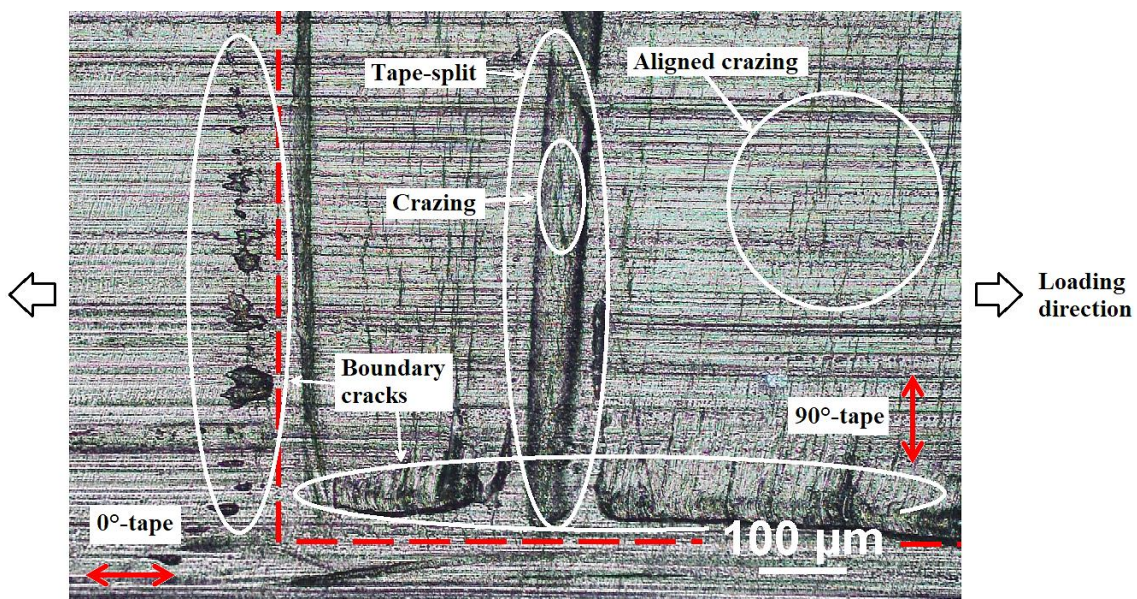
Figure 4.3 Optical micrograph showing different types of damage in a 0.3 mm SRPP tensile specimen. Dotted lines divide regions where surface tapes are at 0° and 90° to the applied load.

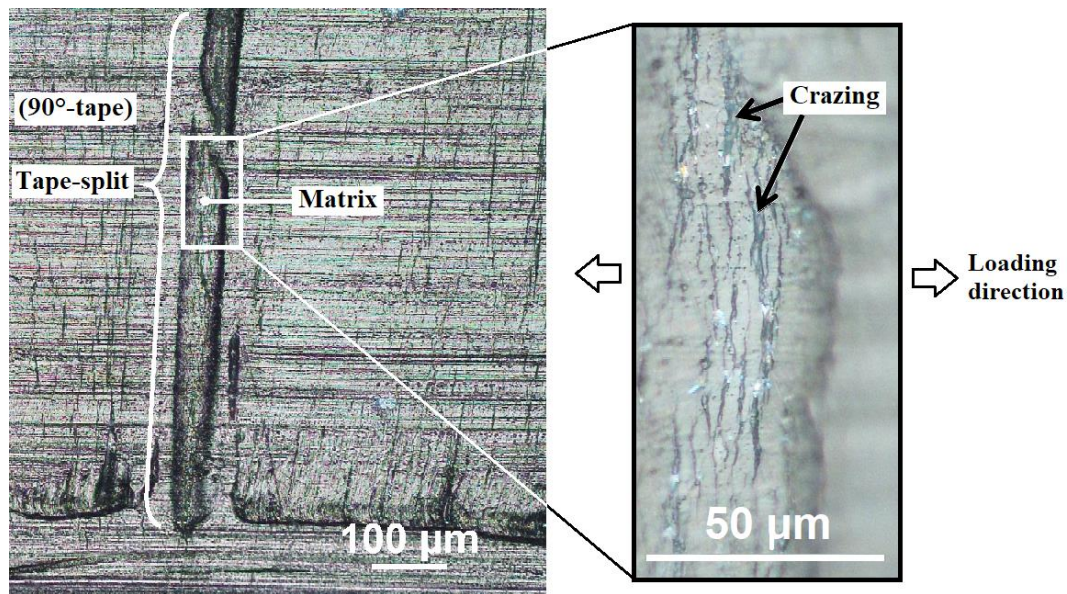
Figure 4.7 Optical micrograph of crazing on a surface exposed from a split in a 90°-tape of a 0.3 mm SRPP tensile specimen.

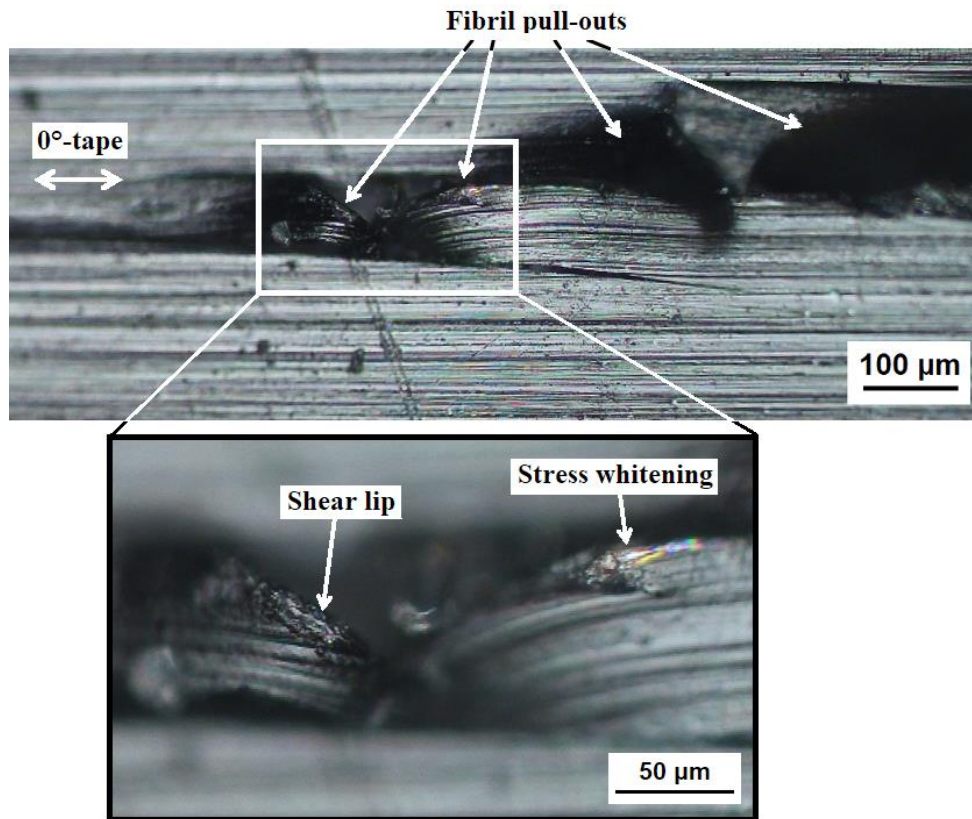
Figure 4.10 Optical micrographs of fibril pull-outs in a 1.0 mm SRPP tensile specimen.

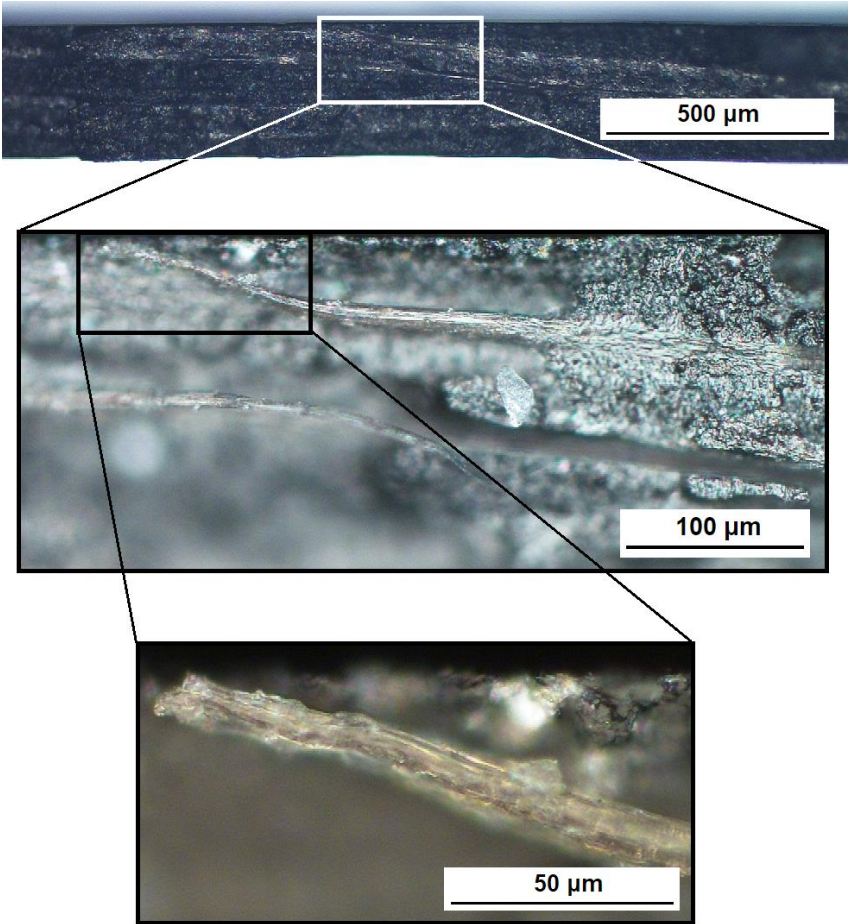
Figure 4.12 Optical micrograph of a fracture surface of a 0.3 mm SRPP tensile specimen. The direction of the applied load is orthogonal to the page.

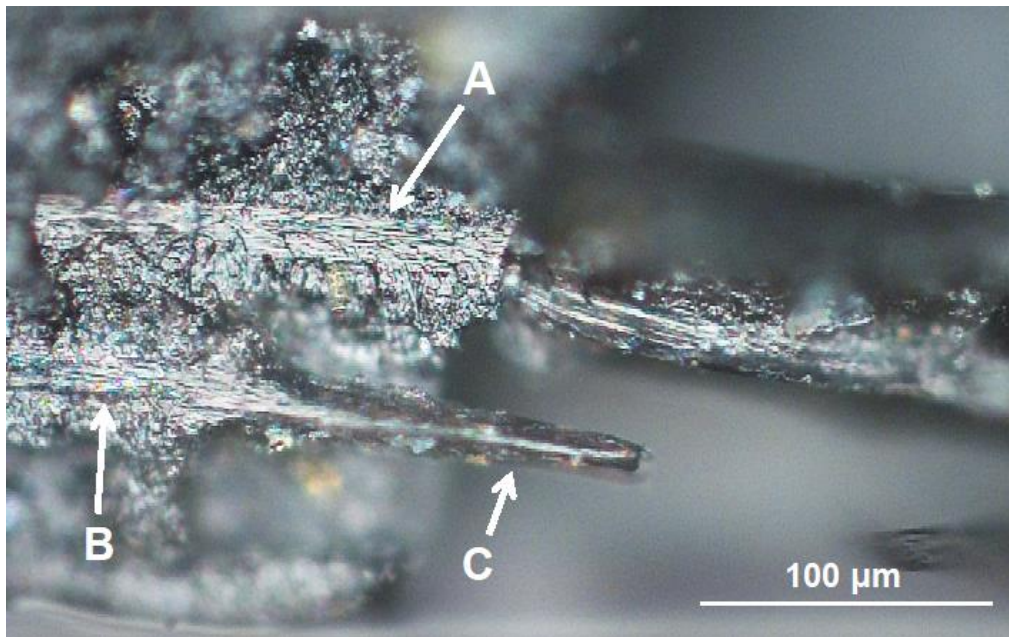
Figure 4.13 Optical micrograph of a fracture surface of a 0.3 mm SRPP tensile specimen, showing boundaries between 90°-tape and the matrix (A and B) and a fibril pull-out (C).

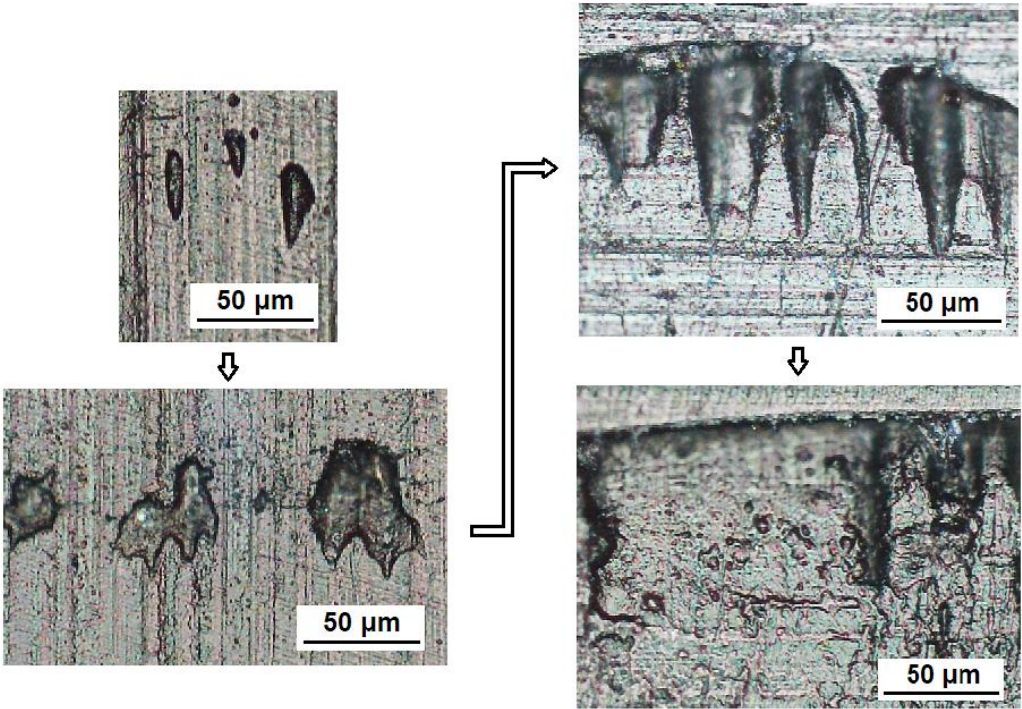
Figure 4.28 Boundary cracks between orthogonal tapes in 0.3 mm SRPP tensile specimens, depicting the process of the matrix damage development.

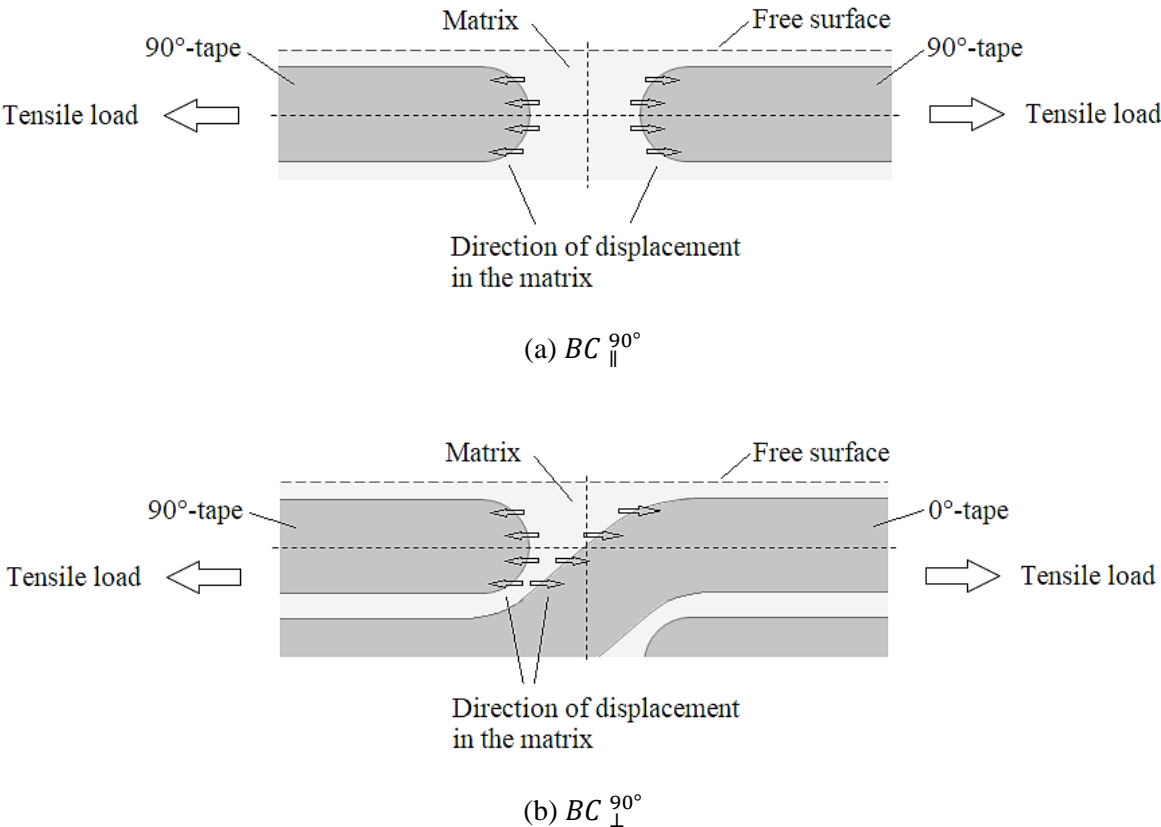
Figure 4.29 Cross-sections of boundary cracks on the surface that are oriented at 90° to the loading direction, a) between two 90° -tapes ($BC_{\parallel}^{90^\circ}$), and b) between 0° and 90° -tapes ($BC_{\perp}^{90^\circ}$).

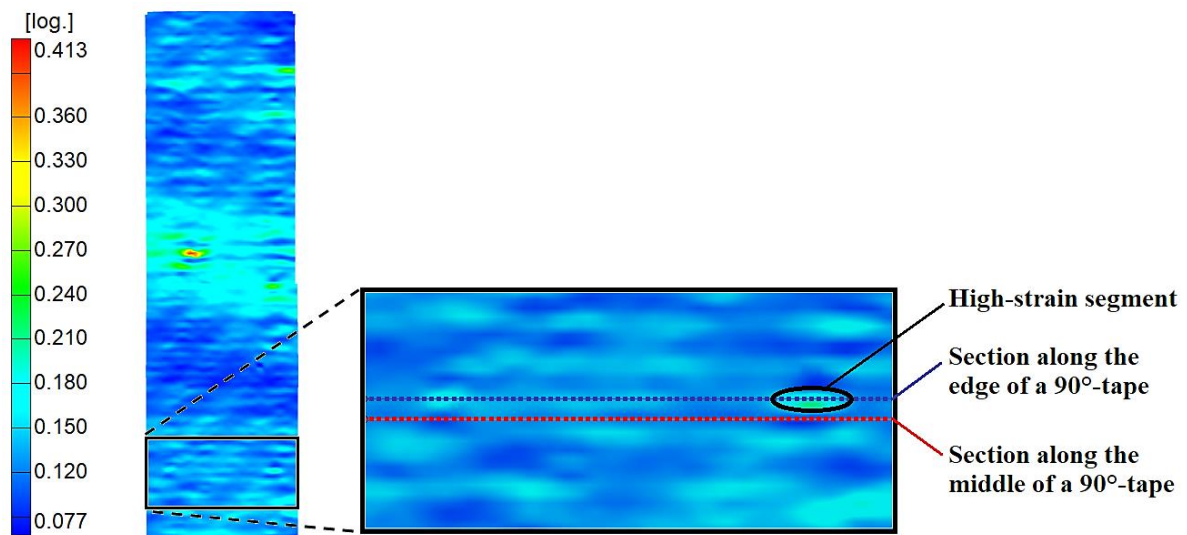
Figure 4.34 First principal strain on a surface of a 0.3 mm SRPP tensile specimen at an applied strain of 13.3%, showing an example of a high-strain segment and sections along the edge and the middle of a 90° -tape.

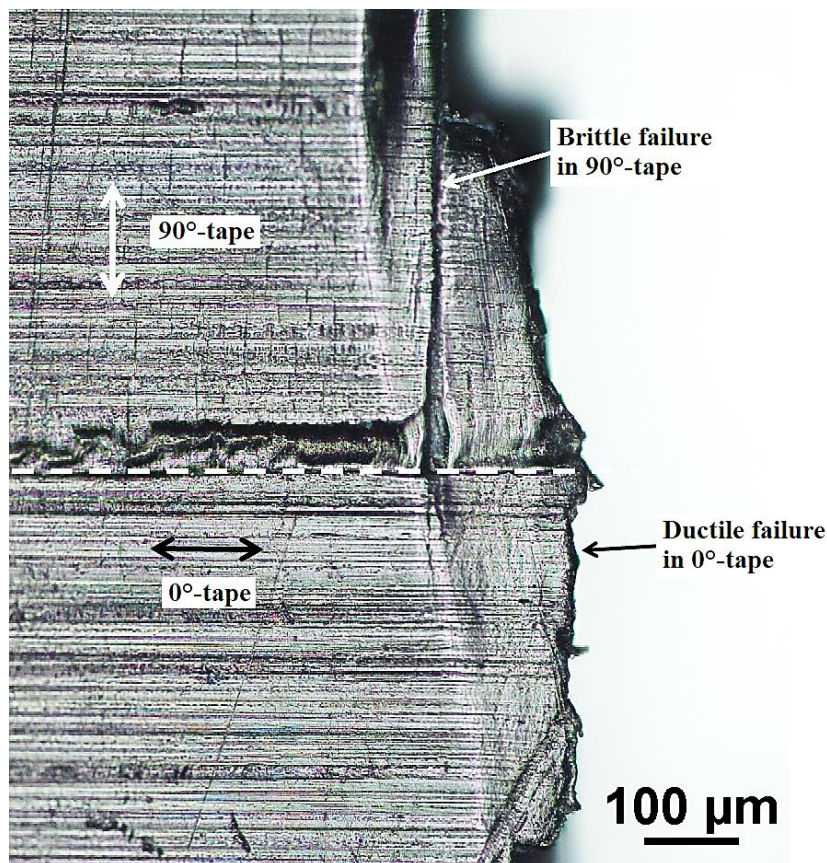
Figure 4.50 Optical micrograph of a 0.3 mm SRPP tensile specimen, pointing out brittle failure in 90°-tape and ductile failure in 0°-tape along the fracture path.

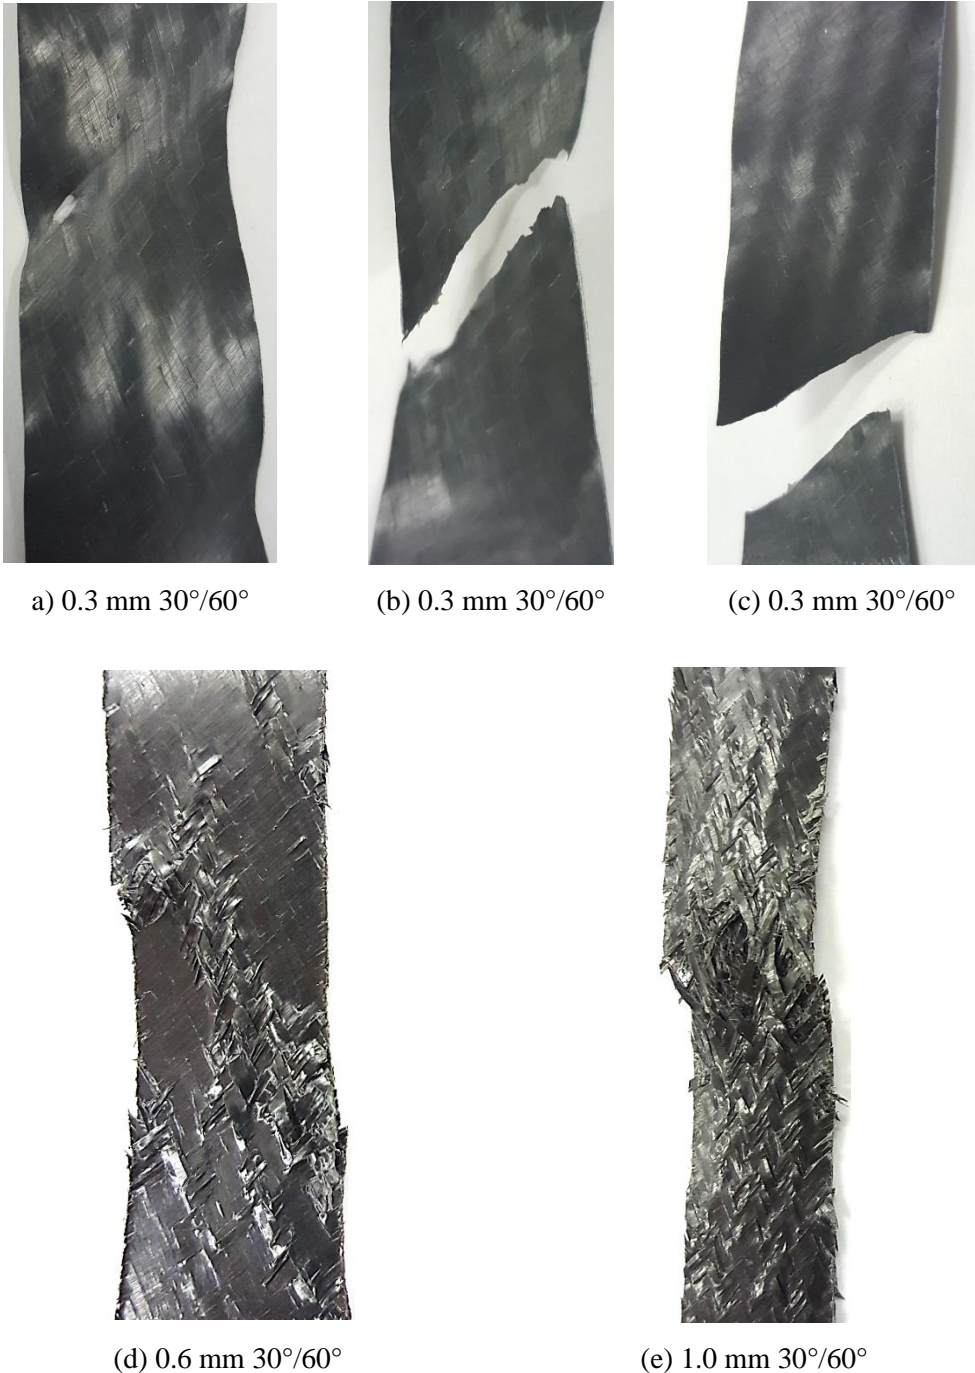
Figure 5.6 Photographs of 0.3 mm (a–c), 0.6 mm (d) and 1.0 mm (e) 30°/60° SRPP tensile test specimens at failure.

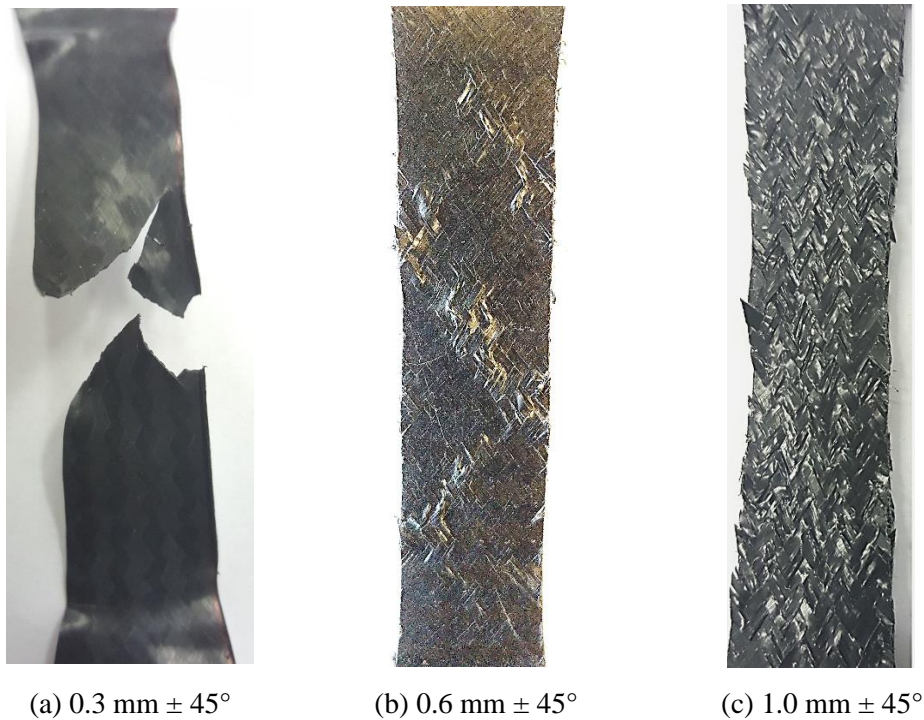
Figure 5.7 Photographs of 0.3 mm (a), 0.6 mm (b) and 1.0 mm (c) \pm 45° SRPP tensile test specimens at failure.

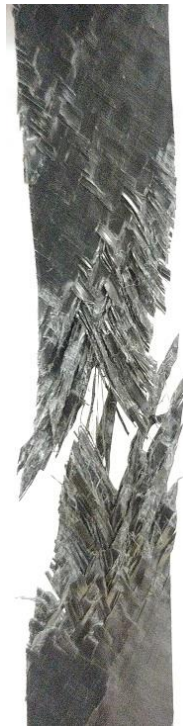
Figure 5.9 Separation of a 0.6 mm $30^\circ/60^\circ$ specimen after failure.

It should be mentioned that the photographs in Figures 5.6–5.8 represent specimens at failure, when the applied load has reached the maximum value and dropped by 2–3%. At this point, the thicker specimens have not separated completely into two pieces but are considered to have reached the failure point, since the specimen will be unable to carry any further load very shortly after this point. Further displacement

does separate the specimen into two pieces, as shown in Figure 5.9. Such behaviour contrasts to the separation of the $0^\circ/90^\circ$ specimens into two parts immediately upon reaching the maximum load.

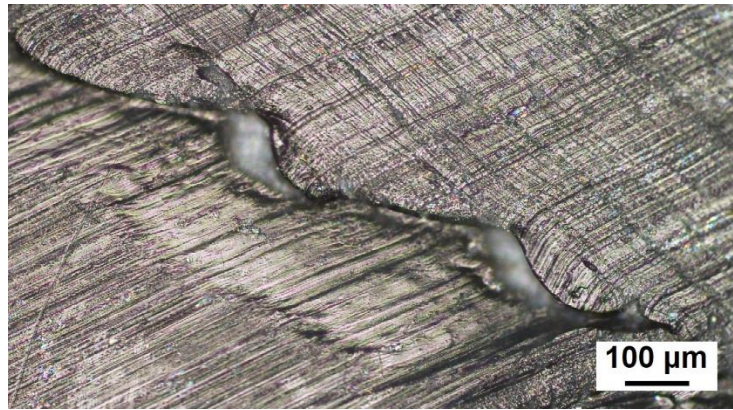
Figure 5.12 Optical micrographs of boundary cracks in 0.3 mm $\pm 45^\circ$ SRPP tensile test specimens.

In off-axis specimens, boundary cracks can propagate under combined fracture modes of Mode I (tensile opening) and Mode II (in-plane shear), in contrast to the boundary cracks propagating only in Mode I in the 0°/90° specimens. An example is shown in Figure 5.12. This type of boundary crack occurs more frequently in $\pm 45^\circ$ specimens than in 30°/60° specimens.

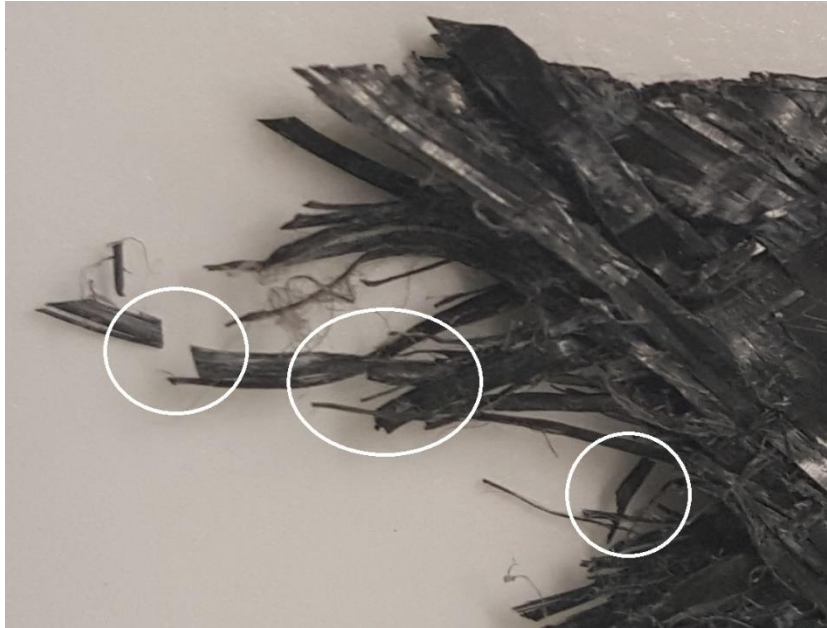
Figure 5.24 Pull-outs and fracture of tapes and fibrils in a 1.0 mm $\pm 45^\circ$ SRPP tensile test specimen after failure. Examples of fractured tapes and fibrils are highlighted. Direction of load is horizontal in the image.

In the off-axis specimens, the majority of the tape and fibril pull-outs occur from the edges of the specimens, and only small amount fracture laterally, as shown in Figure 5.24 in the next page. This is because one or both ends of all tapes in the specimen are on the edge of the specimen, which are only constrained by the adhesion to the surrounding material. A pull-out occurs when the interfacial shear strength at the tape–matrix interface, or the matrix shear strength, are overcome. This requires less stress than is required to break the tape or the fibril laterally (strength in the reinforcing direction must be overcome). Therefore, tapes and fibrils pull out from the edges far more often than they fracture laterally in the tape.

This contrasts to the behaviour of the 0°/90° specimens, in which most fibril pull-outs occur in 0°-tapes when they fracture at the point of specimen failure. The difference arises due to the 0°-tapes in 0°/90°

specimens being fixed at both ends by mechanical grips. In this case, fibrils' longitudinal strength must be overcome for them to fracture first, before they can pull out. As such, fibril pull-outs in $0^\circ/90^\circ$ specimens occurred at much higher levels of applied stress, mostly at specimen failure. In comparison, tape and fibril pull-outs in the off-axis specimens occurred before specimen failure.

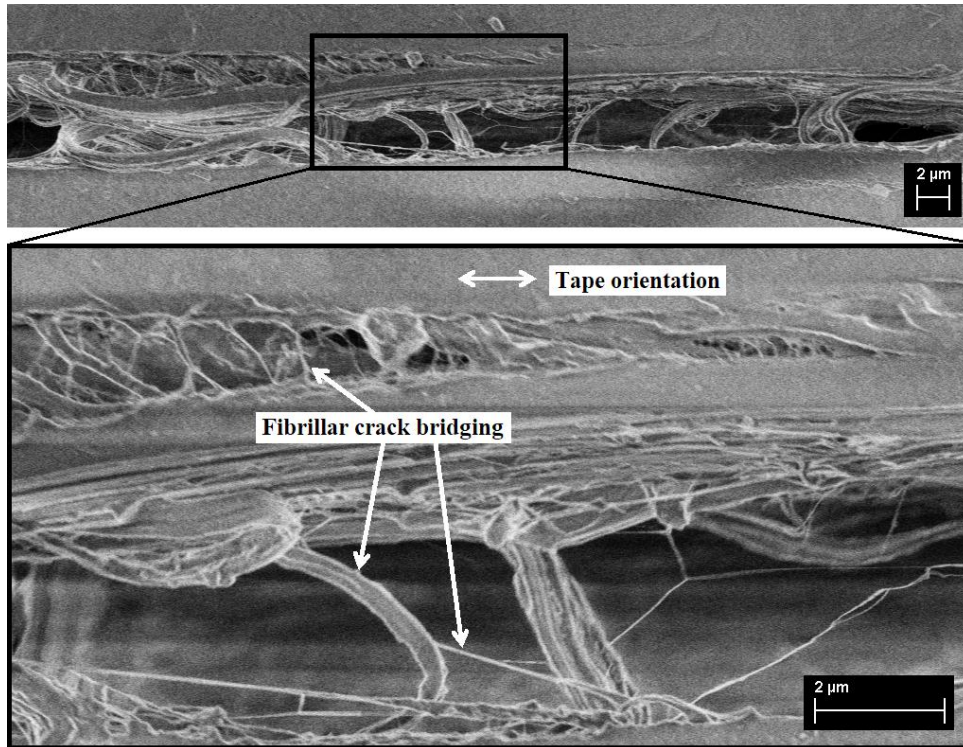
Figure 5.29 Scanning electron micrographs of fibrillar crack bridging in a tape-split of a 0.6 mm 30°/60° SRPP tensile test specimen. Magnification = 5,000x (top), 20,000x (bottom), EHT = 1.00kV. Direction of the load is at 60° to the tape orientation shown.

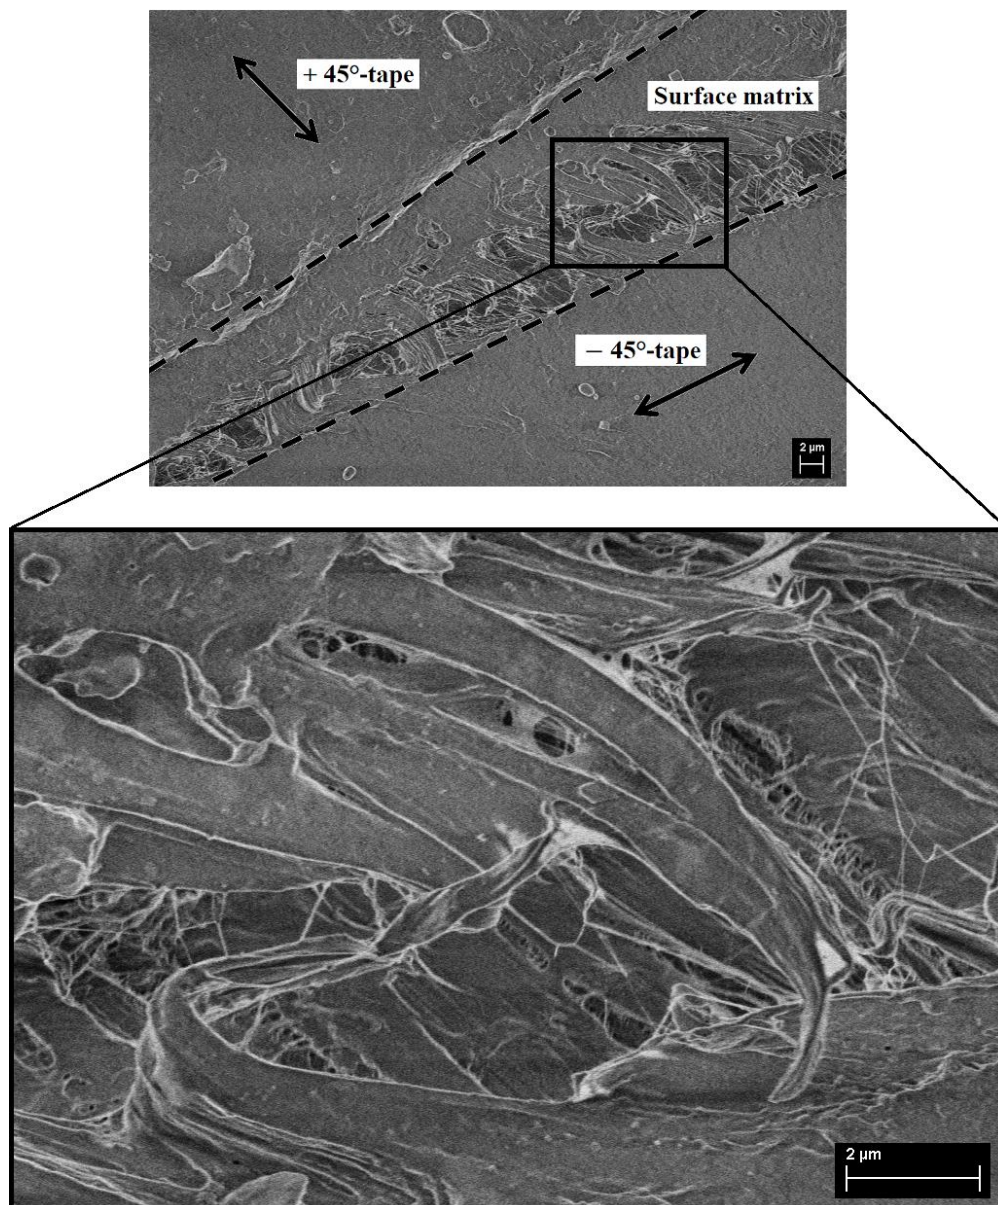
Figure 5.33 Scanning electron micrographs of matrix damage at a boundary between +45° and -45°-tapes of a 0.6 mm \pm 45° SRPP tensile test specimen. Magnification = 5,000x (top), 20,000x (bottom), EHT = 1.00kV.

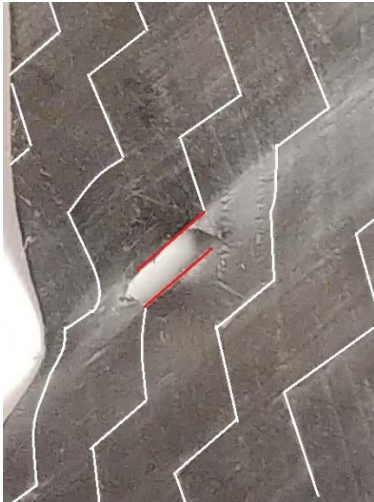
Figure 5.36 Failures along a boundary between 30° and 60°-tapes in a 0.3 mm 30°/60° SRPP tensile test specimen. White lines indicate boundaries between 30° and 60°-tapes and red lines on either side of the damage represent the same tape boundary.

Failure in off-axis 0.3 mm specimens appears to initiate from a boundary crack, as in the case of 0°/90° specimens. However, critical boundary cracks in off-axis 0.3 mm specimens occur between tapes of different orientations and they propagate through the thickness, causing slits or holes to appear, as shown in Figures 5.36 and 5.37. As can be seen, the critical boundary cracks exhibit blunt crack tips and cause a ductile type of failure in the tapes, which must be due to the weave geometry based on the analysis of 0°/90° specimens in Chapter 4. (Interestingly, there are rare instances where slits do not occur along tape boundaries, as shown in Figure 5.38 but they are not related to specimen failure.) The fact that critical boundary cracks occur between differently oriented tapes indicates that damage development

from the warp and weft tapes rotating in the opposite directions is more damaging than matrix cracks between parallel tapes in 0.3 mm off-axis specimens.

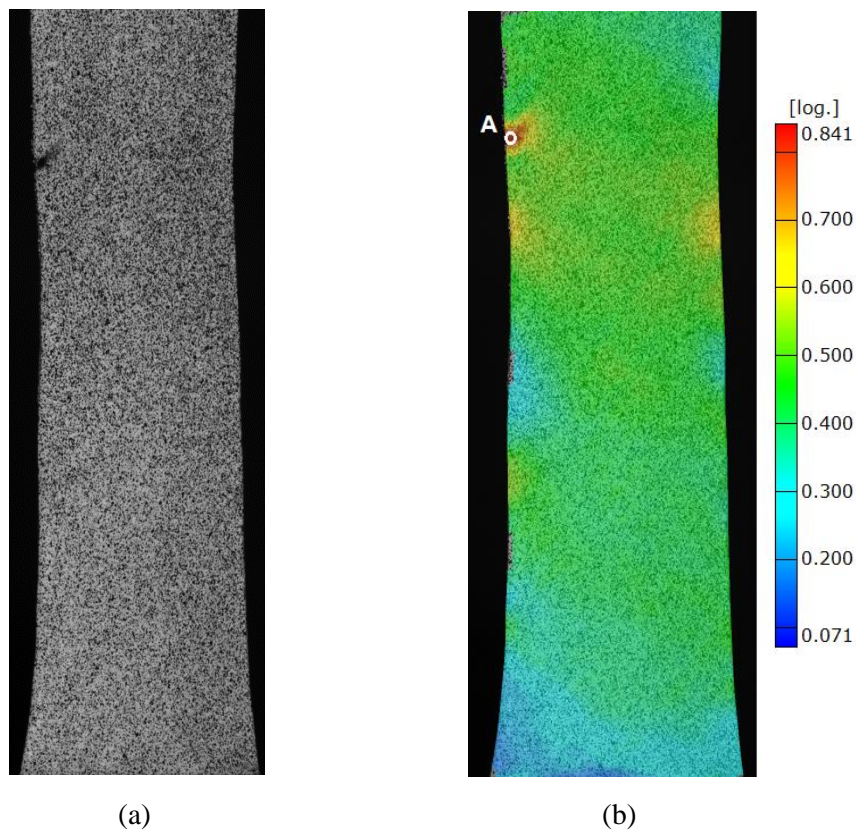
Figure 5.44 a) Photograph and b) first principal strain (ϵ_{p1}) in a 0.3 mm $30^\circ/60^\circ$ SRPP tensile test specimen at an applied strain of 41.5%.

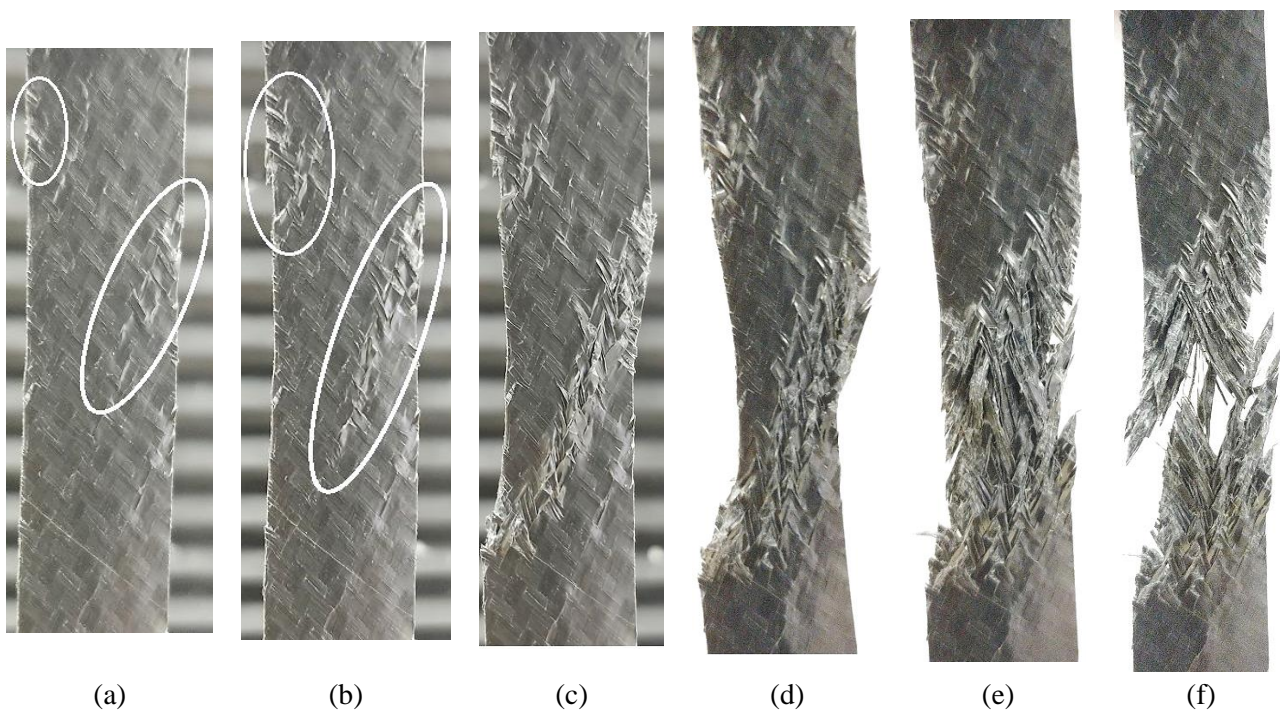
Figure 5.52 Progression of damage until failure (a–c) and after failure (d–f) in a 0.6 mm 30°/60° SRPP specimen.

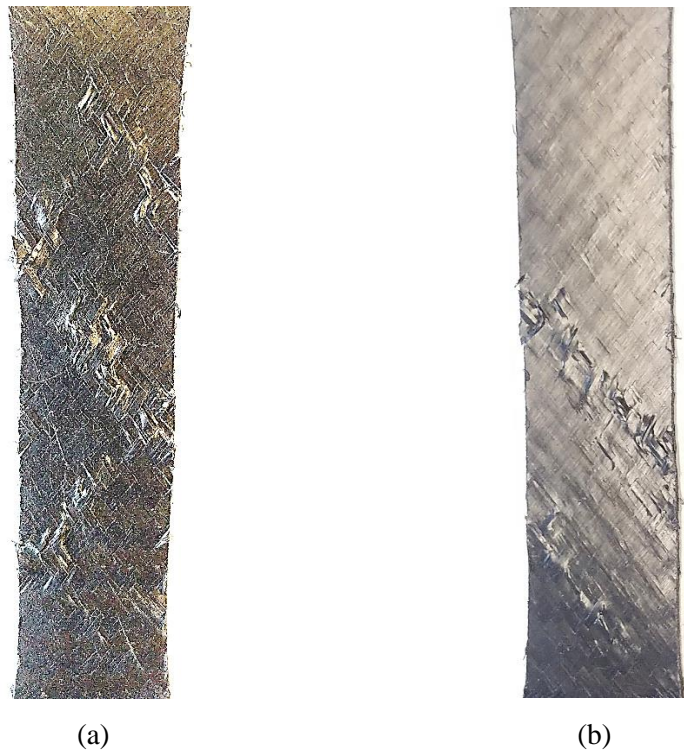
Figure 5.54 0.6 mm \pm 45° SRPP tensile test specimens at failure with cluster of damages propagating along a) both tape directions and b) a single tape direction.

Similar damage progression and failure occurs in 0.6 mm $\pm 45^\circ$ specimens, except that in these cases, the cluster of damage propagates in +45°-tape direction as easily as in -45°-tape direction, as shown in Figure 5.54a. In some specimens, however, pull-outs seem to occur preferentially along the warp direction first, rather than along the weft direction, as seen in Figure 5.54b.

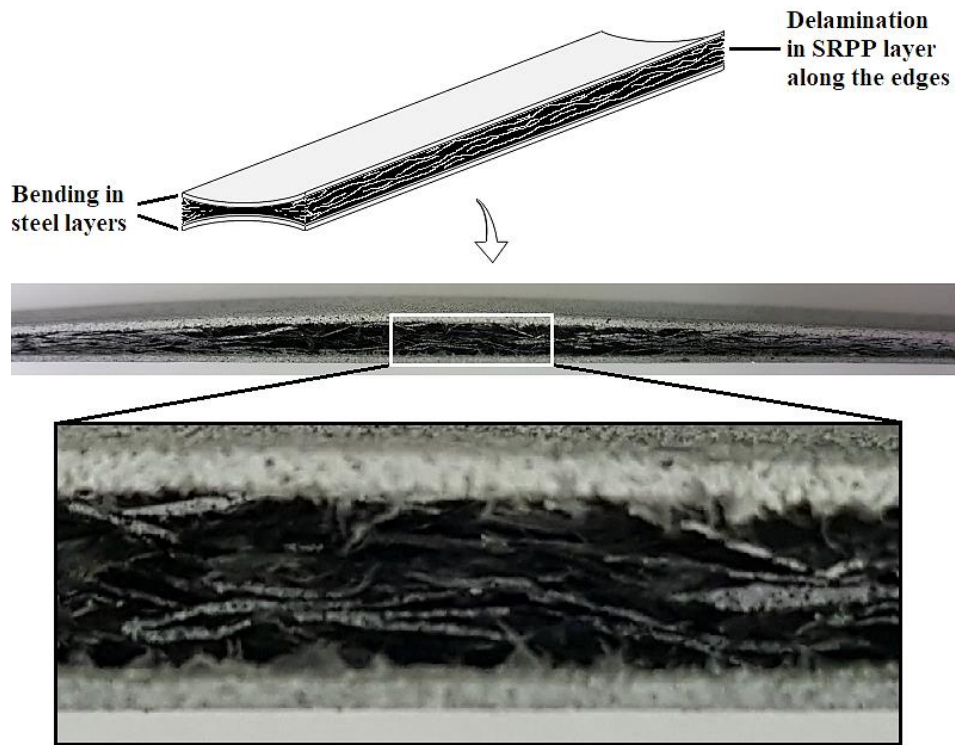
Figure 5.60 Delamination within the SRPP layer of a $\pm 45^\circ$ SRPP/steel FML tensile test specimen caused by out-of-plane bending in the steel layers. Direction of the applied load is horizontal in the image.

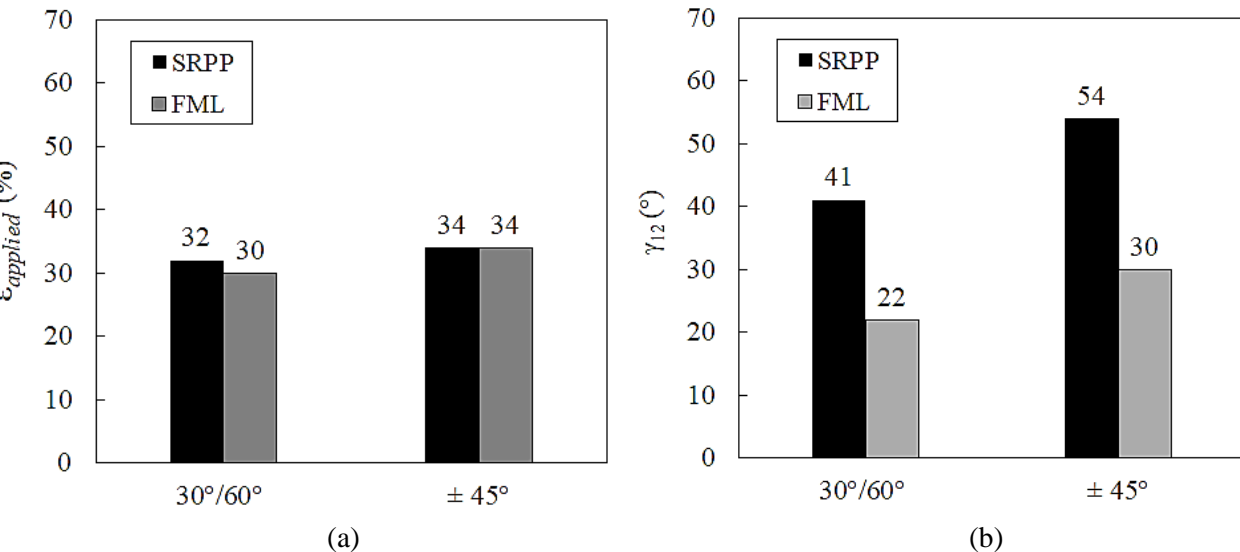
Figure 5.67 a) Applied strain in the loading direction ($\epsilon_{applied}$) and b) maximum shear angle (γ_{12}) at failure of 1.0 mm SRPP and SRPP/steel FML specimens, tested at 30°/60° and ± 45° to the applied load

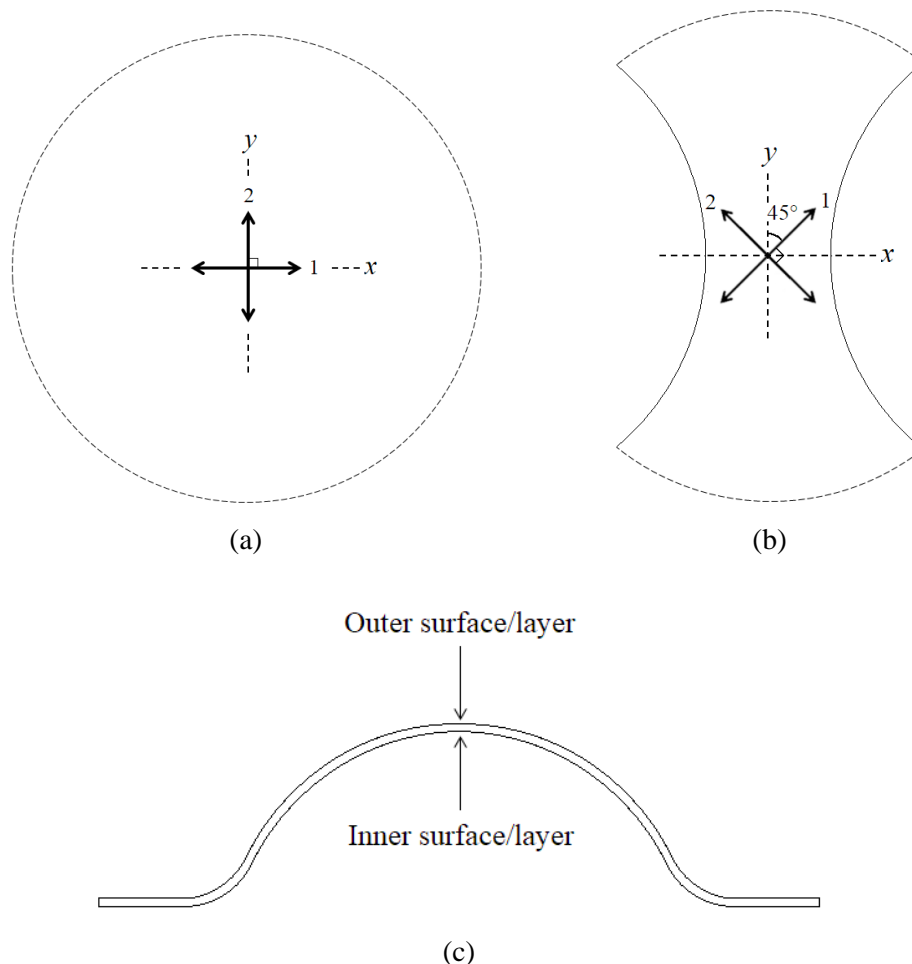
Figure 6.1 Local x - y coordinates and tape orientations 1 and 2 in the undeformed state, for a) circular and b) hourglass specimens in induced-biaxial deformation tests. Dotted perimeters represent approximate boundaries for areas visible to the DIC system. c) Outer and inner surfaces or layers shown on a cross-section of a deformed specimen.
