Deformation and Failure Behaviour of Self-reinforced Polypropylene and Self-reinforced Polypropylene/steel Fibre Metal Laminate

Jae Young Nam

A thesis submitted for the degree of Doctor of Philosophy of The Australian National University.

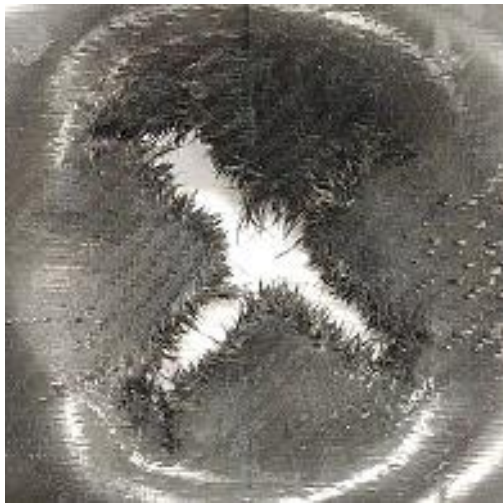
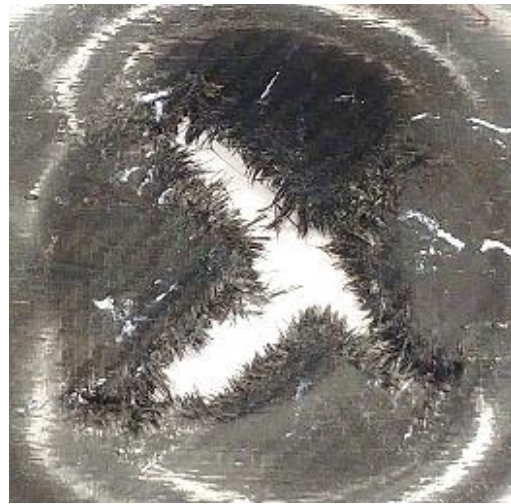
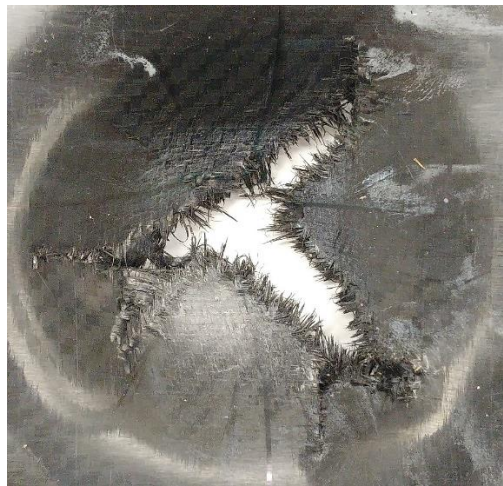
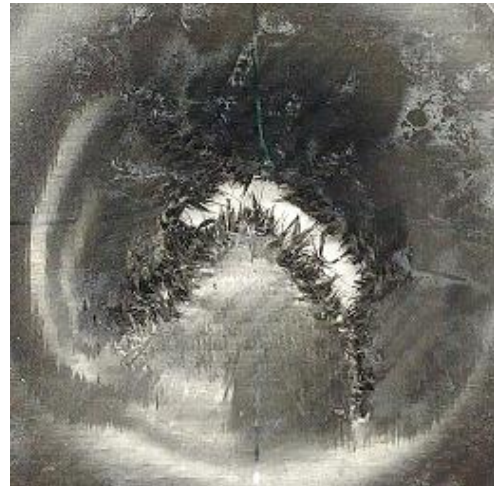
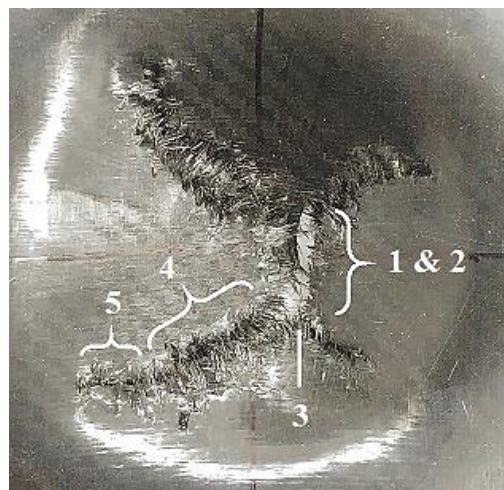
Figure 6.2 Inner surfaces of failed circular SRPP induced-biaxial deformation test specimens. Corners of the images are located on the die bend. Stages of critical failure initiation (1) and propagation (2 – 5) are indicated in (e).

The critical failure in circular SRPP IBD test specimens occur as shown in Figure 6.2, where the critical failure refers to the state of a specimen which cannot bear further load. For IBD tests, this occurs with a sharp drop in the load. The propagation of cracks and fractures during the failure process occurs almost instantaneously, to the point where the process cannot be captured using a frame rate of 15 frames per second. However, it is not hard to predict, from examining various specimens, that failure initiates from the fracture of tapes in the centre region of the specimen. It is also possible to categorise the failure process into five stages, as shown in Figure 6.2e, from the initiation of failure at stage 1, to the propagation of failure in stages 2–5. The following paragraphs will analyse the failure behaviour through stages 2–5, before the initiation of failure (stage 1) is explained later on.

As can be seen in Figure 6.2, most specimens exhibit roughly equal amounts of fibril pull-outs in both tape directions at the centre. However, the specimen in Figure 6.2e exhibits an additional phase of failure propagation (stage 2), where the failure path extends in one of the tape orientations (direction 2) and causes more fibril pull-outs in one tape direction (direction 1). A close-up photo of the fibril pull-outs is shown in Figure 6.3. It can be seen from the figure that the damage characteristics resemble those of failure of the $0^\circ/90^\circ$ tensile specimens, which suggests that the critical failure in circular IBD test specimens occurs from fibrillation and fracture of tapes in the middle, due to the tension in the reinforcing direction.

At stage 4, failure propagates outwards from the centre along diagonals that are, in most cases, oriented at approximately 45° to the reinforcing directions. Damage along some diagonals may not result in noticeable tape fracture and pull-outs, as shown in Figures 6.1c and d. It is hypothesised that the failure propagates diagonally to the tape directions because the initial fracture of tapes at the centre causes the unloading of tapes along the meridian lines. The reductions in tapes along their lengths in both directions would cause stretching of the material between the meridian lines, causing the material to shear about the tape orientations, as shown in Figure 6.4. Then, the tapes would fracture due to the tensile stress built-up along the tapes. Unloading also occurs in fractured tapes, causing further tensile fracture of tapes between the meridian lines, and so on, causing the fracture to propagate diagonally to the tape

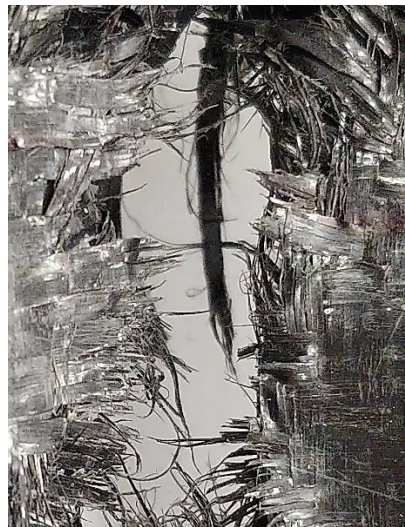
Figure 6.3 Close up of failure at the centre of the specimen shown in Figure 6.2e.

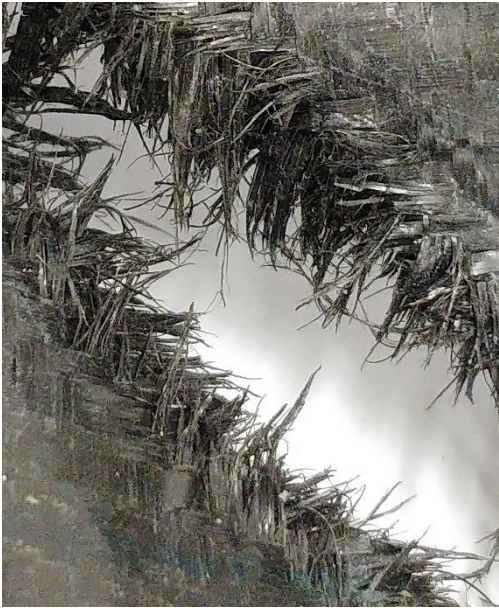
Figure 6.5 Fibril pull-outs along a diagonal failure path from the centre of a specimen.

directions. Hence, the failure along the diagonals also exhibit characteristics of tensile failure of the tapes, as shown in Figure 6.5.

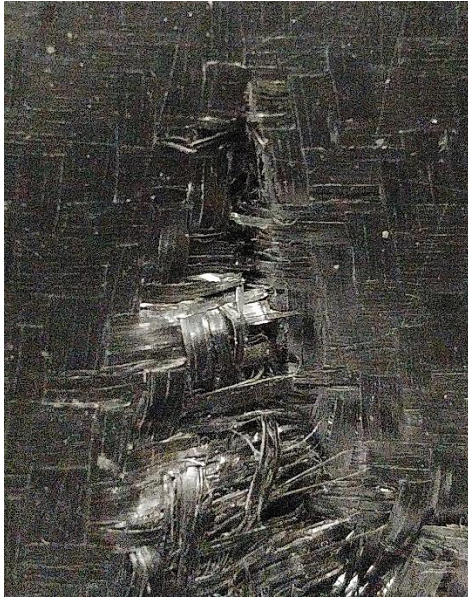
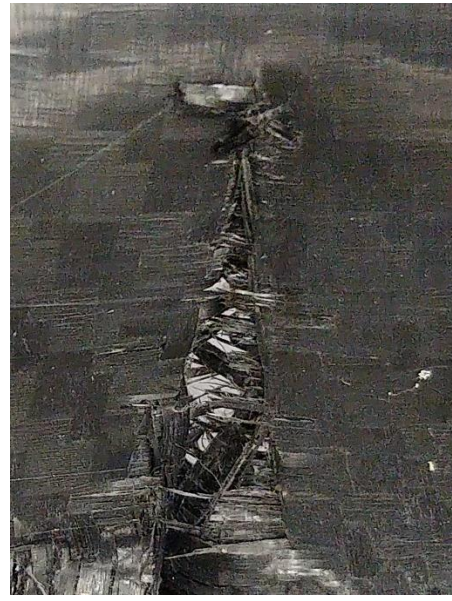
Figure 6.6 Propagation of failure in the direction of tape orientation.

At stage 5, failure can additionally propagate in the direction of one or both tape orientations, as indicated by stage 5 shown in Figure 6.2e and as shown in Figure 6.6. Cracks propagate along the boundary between the tapes as shown. This verifies earlier findings from tensile tests that tape boundaries are the ‘weak’ parts of SRPP, along which damage tends to propagate.

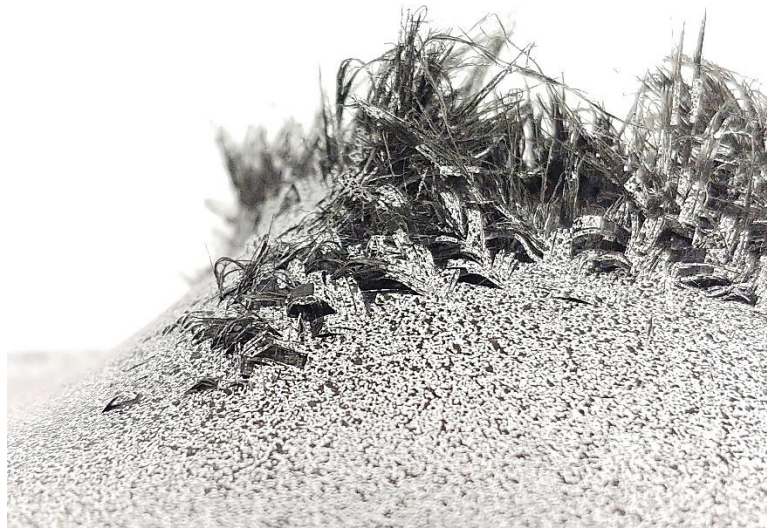
Figure 6.8 Side-view of the outer surface of a specimen, showing fibril pull-outs.

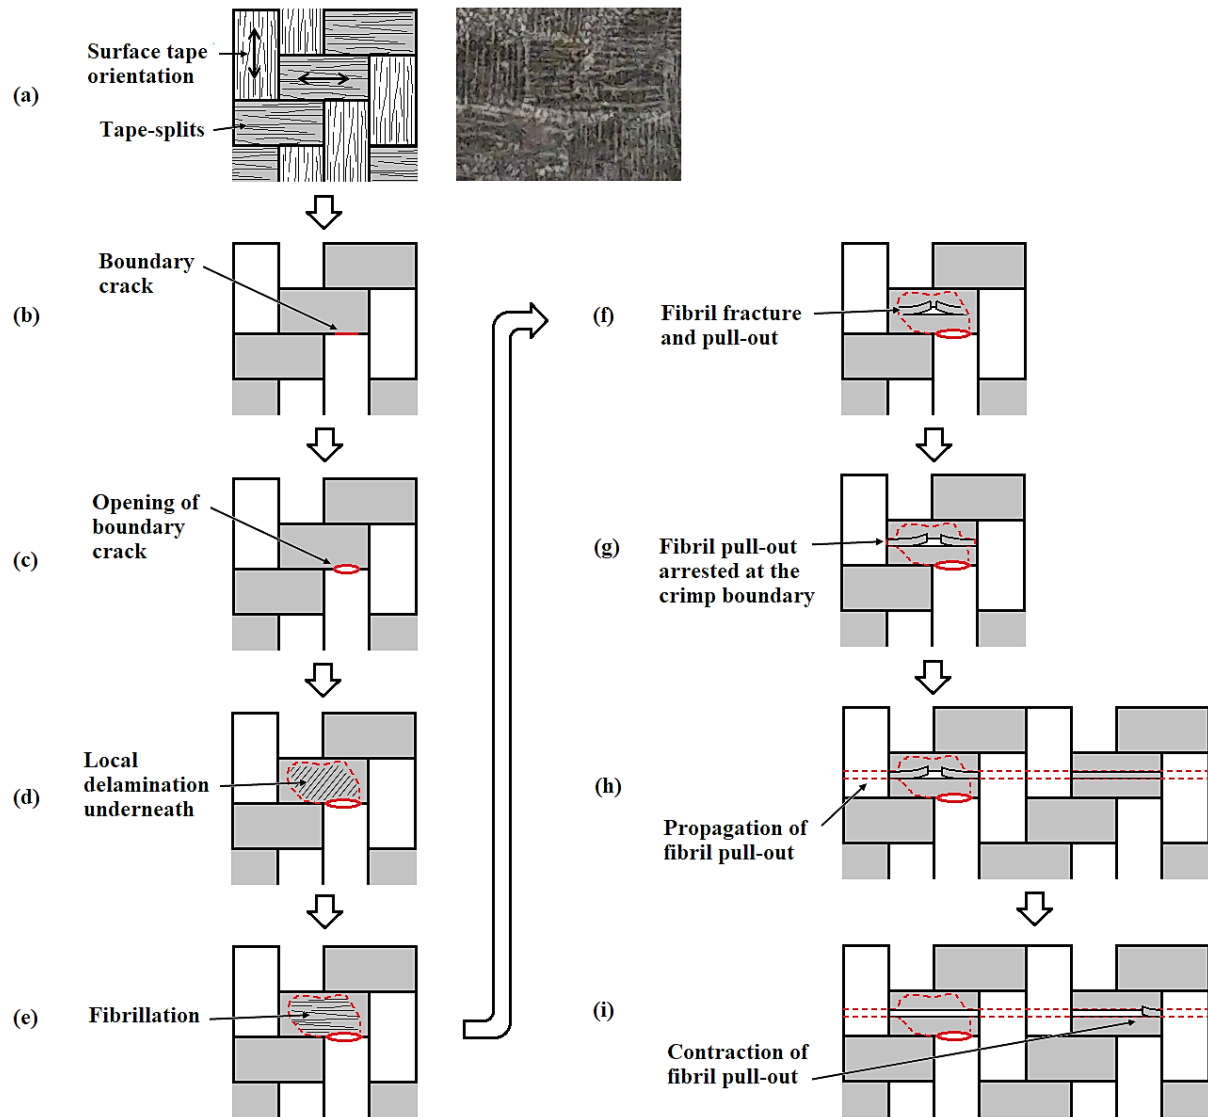
Figure 6.10 Fibril pull-out process in circular SRPP induced-biaxial deformation test specimens.

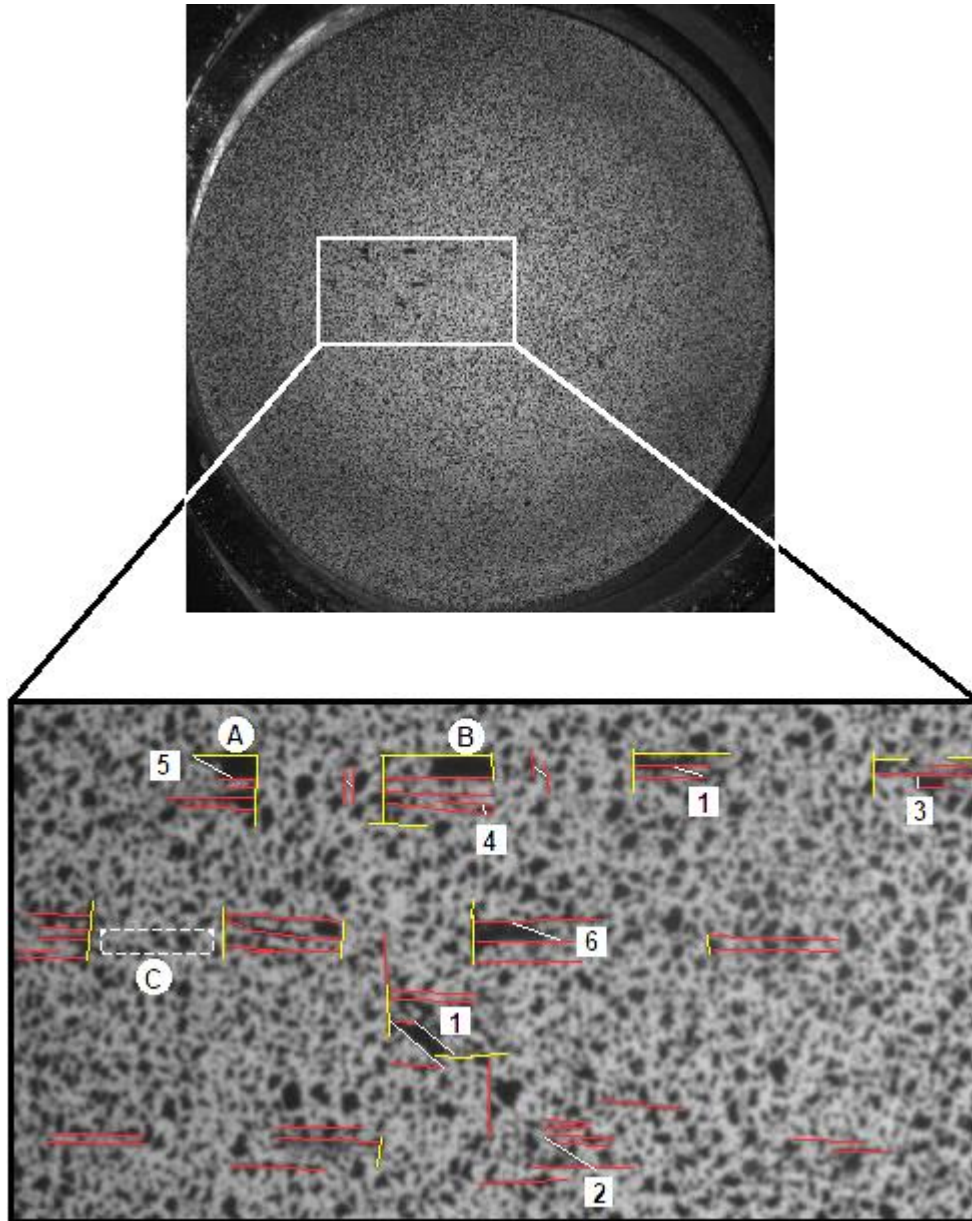
Figure 6.11 Digital image of a region in a circular SRPP induced-biaxial deformation test specimen before failure. Red lines indicate large tape-splits, yellow lines indicate boundary cracks and white lines indicate fractures across fibrils. Fibril fractures that triggered fibril pull-outs are numbered in the order of appearance.

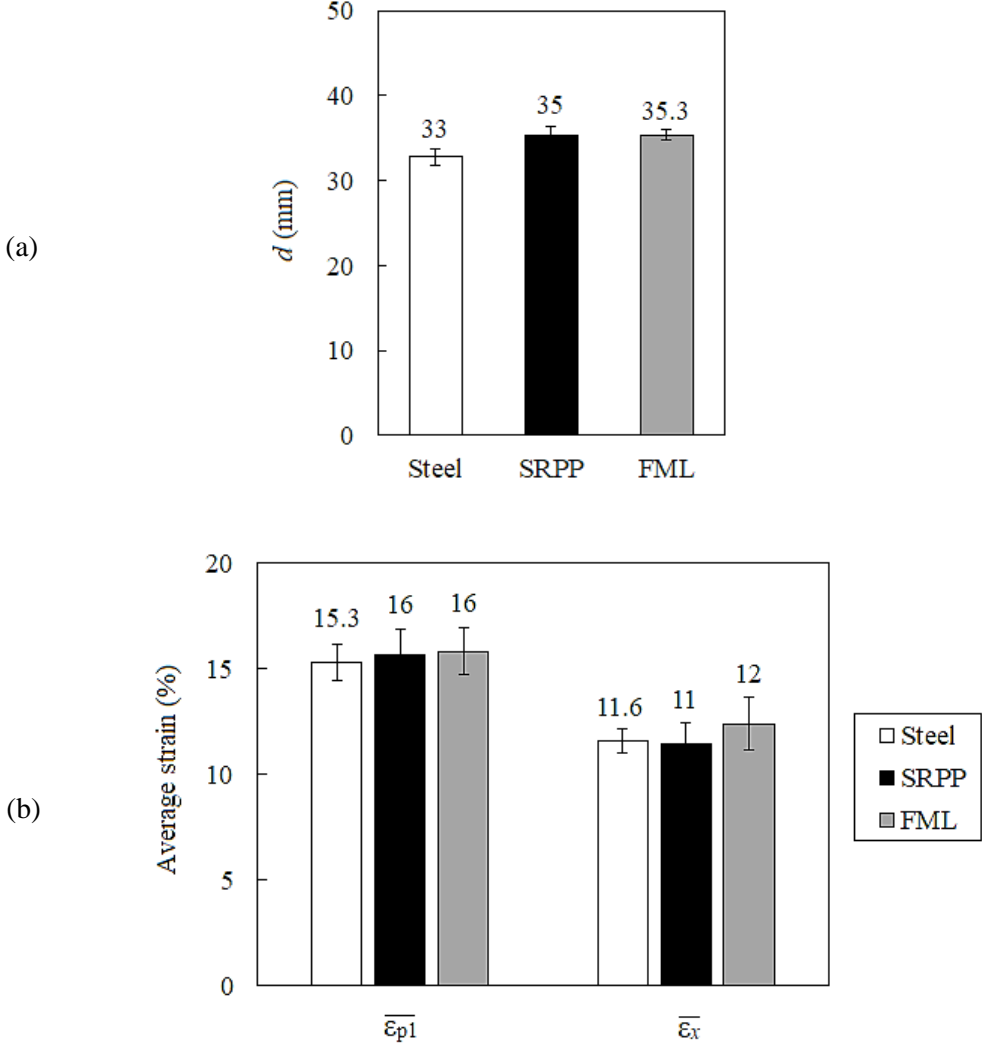
Figure 6.18 a) Punch depth (d), b) average first principal strain ($\overline{\epsilon_{p1}}$) and average strain in x -direction ($\overline{\epsilon_x}$) in circular induced-biaxial deformation tests specimens for steel, SRPP and SRPP/steel FML before failure.

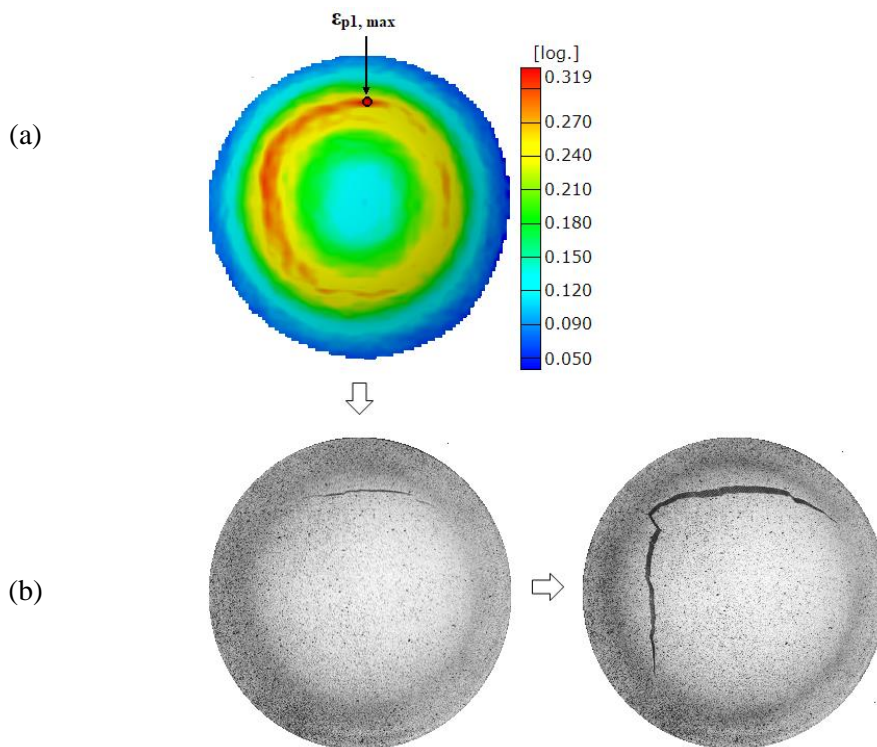
Figure 6.25 Failure in a circular steel induced-biaxial deformation test specimen: a) first principal strain distribution and maximum strain point ($\epsilon_{p1, \max}$) at the last stage before failure, b) tearing (left) and propagation of crack (right) upon failure.
