# USE OF THE HOMOPOLAR GENERATOR TO POWER XENON DISCHARGE TUBES AND SOME ASSOCIATED SWITCHING PROBLEMS

EP-RR 23

E. K. INALL

*March, 1969*

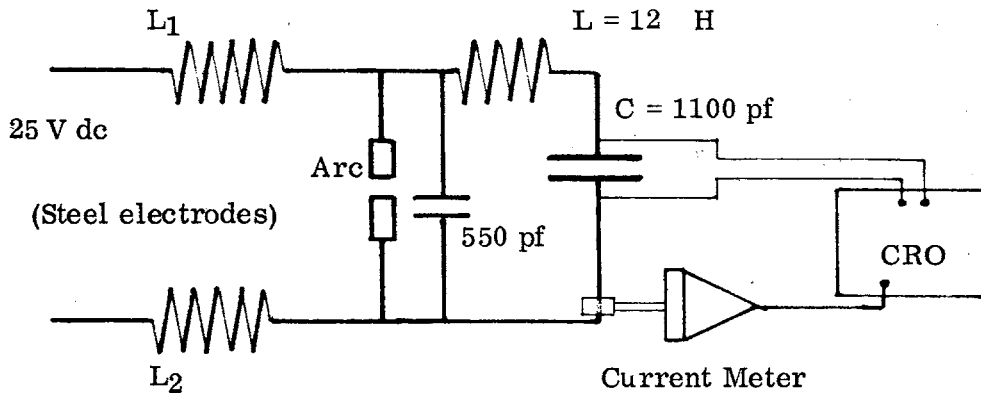
Figure 7 The circuit used to demonstrate the excitation of a tuned circuit by an arc.

When the arc was burning with some molten steel on the surface of the electrodes, the tuned circuit carried a high current at the resonant frequency. No attempt was made to optimise any parameters of the circuit. The current in the circuit was measured as well as the voltage across the condenser, as a check on the calibration of the observations.

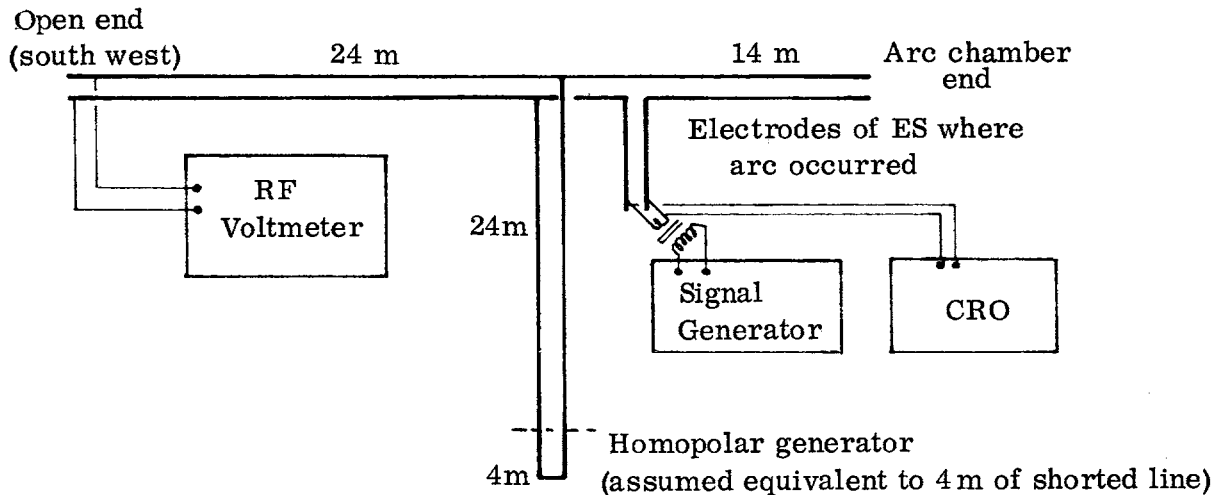
Figure 10 Current used to measure frequencies at which the bus bar system resonates and standing wave patterns occur.

Three resonances with antinodes at the south-west end were observed in the frequency range 0.6 MHz to 2.8 MHz. The dominant one was at 1.5 MHz where a 3.6 fold increase in voltage was observed. The normalised readings over the frequency range are shown in Figure 11. For each of these resonant frequencies, the 14 M length of open bus bars from the switch was less than a quarter wave length long, and therefore was equivalent to a capacitor coupling into a line about 52 M long, open at one end and shorted at the generator end. Frequencies at which the impedance looking into the feed point was inductive and which resonated with the loaded line, gave rise to standing waves with high voltages at the open end. The measurements show the frequencies at which such resonances do occur.
