ASSEMBLY NOTES
MACHINE NO 2

MONTPELLIER

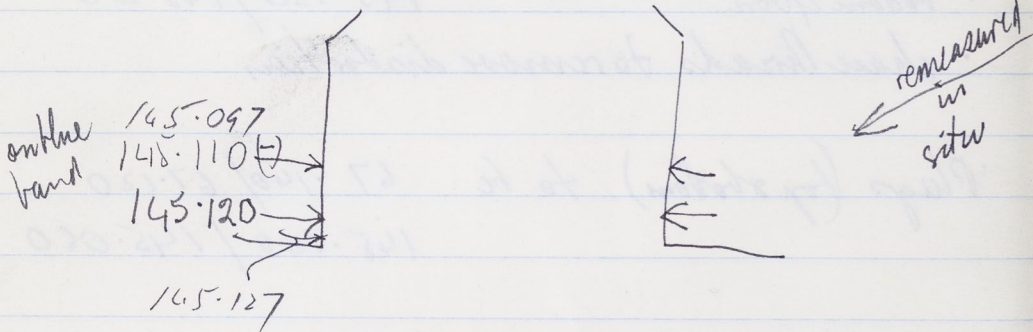
65.650 (micrometer a bit cold; may
be a few μm too big
~20 mm below O-ring

65.582 as far down as can reach
(65 below O-ring groove)

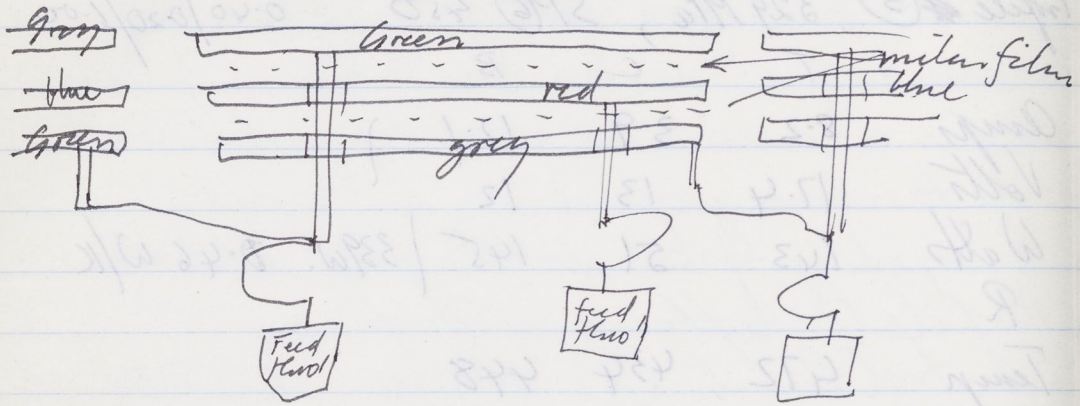
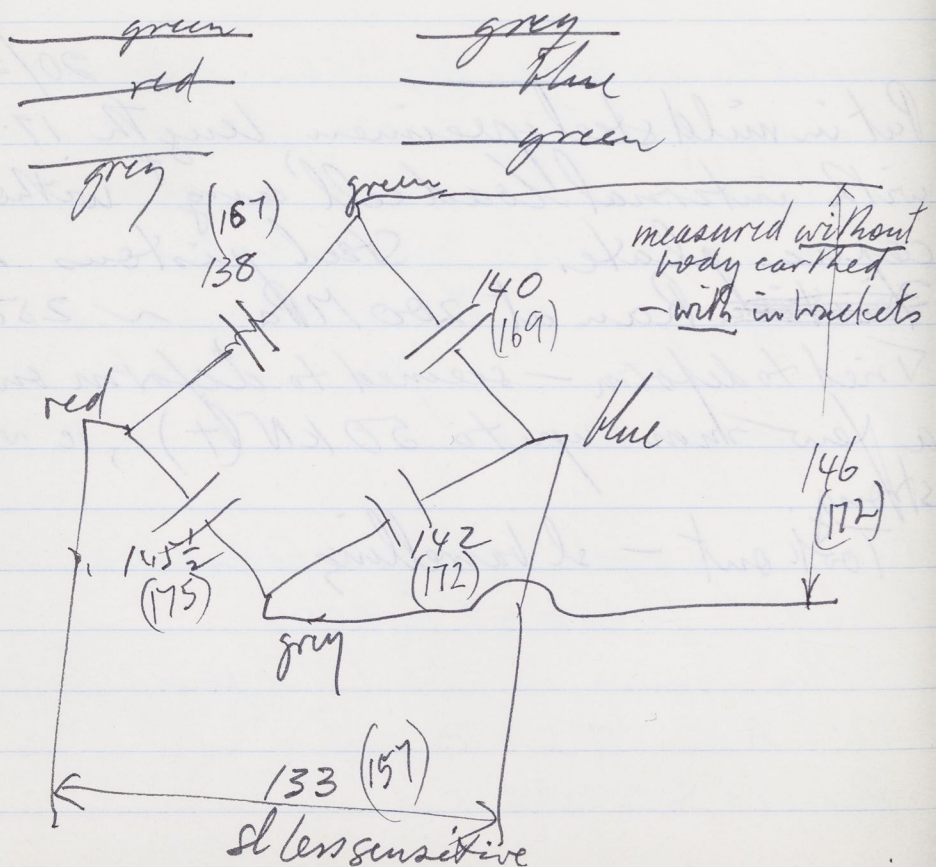
Internal Load Cell

Set up similarly to that in No 1 machine except that the connections to the plates were all brought out downwards thro' holes in the lower plates & the connections made more directly to the feed throughs. An extra layer of teflon insulation (1.1 ϕ) was put over the leads down the stem, which fitted into 1mm wide grooves.
