# ASSEMBLY NOTES MACHINE NO 3

MINNEAPOLIS

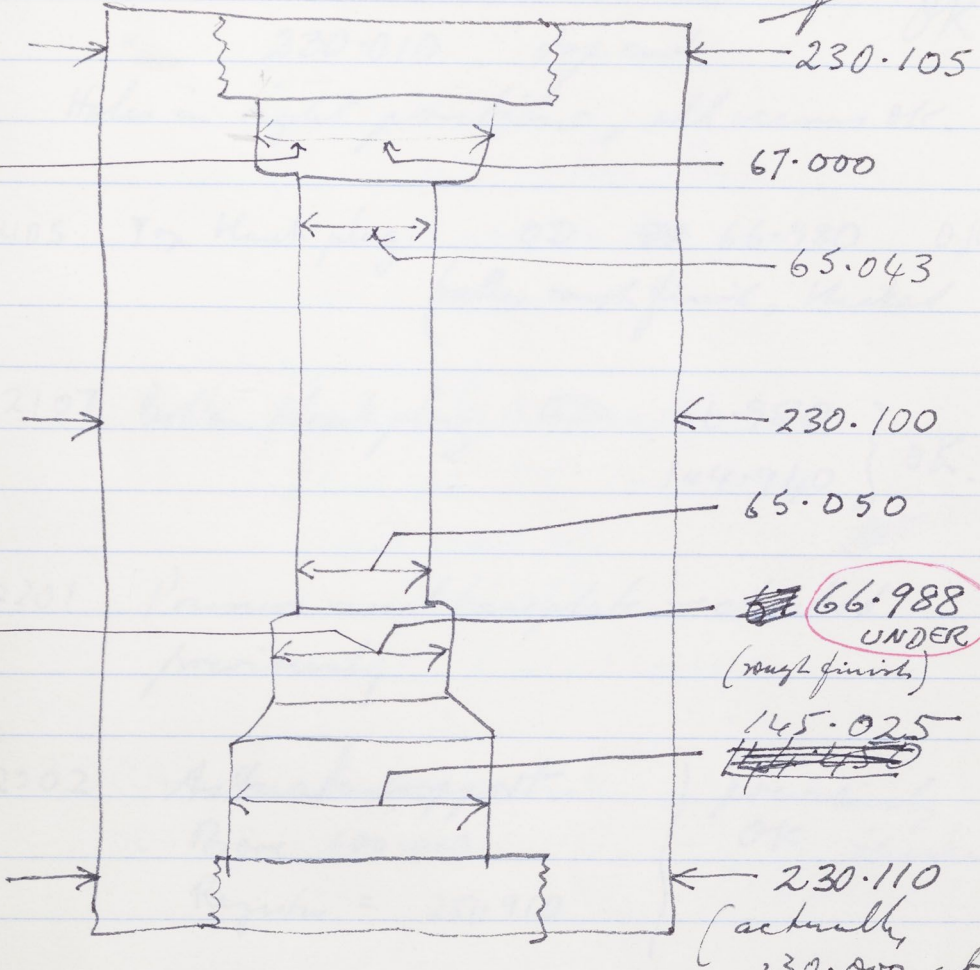
210/8 Pressure vessel

All within spec.

- 2103 ~~Bottom~~ <sup>Top</sup> nut fits OK
- 2104 Inner nut fits OK
- 2106 Bottom nut ~~light~~ OK, fairly snug.

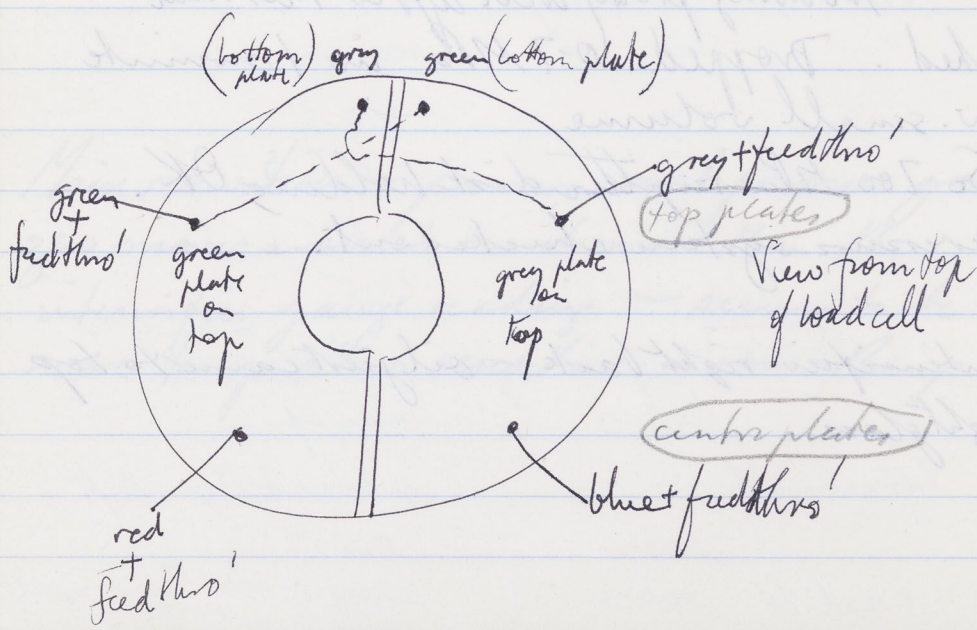
Two reservations about this load cell:

- 1) finish in feed-through seatings
- 2) screwholes for screws holding centre plate not tapped quite vertically — had to use loose screws & fits to assemble OK.

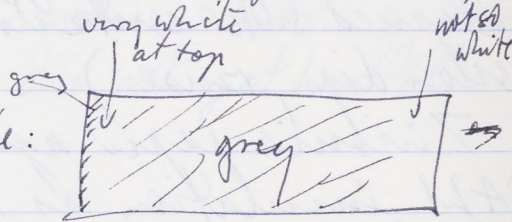
Other segments similar; slight asymmetry in temp contours.

Core: Cracks - bottom of bottom winding } both cracked  
- top of top winding } off & fell apart  
- bottom longit crack runs up to bottom of centre winding

Longit. crack in PSZ piece as in last furnace.

<sup>Crack</sup>  
Crack at bottom of bottom ~~winding~~ winding fairly  
disrupted - open during running

Crack at top of top winding clean but at  
higher T than C contour.

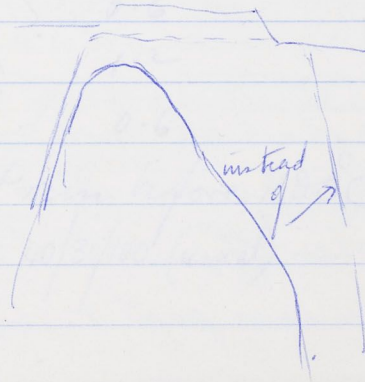
T<sub>profile</sub>

Getting worse at 700°C. Pressure 130 MPa.  
 Dropped pressure to 100 MPa. Furnace now more responsive

Still ~0.7 W/K.

802  
Dropped pressure further to 90 MPa, immediately  
more responsive but gradient still bad.
