# TOWARDS OPTIMIZATION OF COMPOSITE REPAIR PATCH MANUFACTURING FOR AUTOMATED FIBER PLACEMENT

It is thus the focus of this study to investigate the manufacturability of single-sided composite scarf repair patches using automated fibre placement (AFP). A simulation of the automated process for repair patch manufacturing was performed and a Finite Element (FE) model was built to examine stresses in the repair patch and the adhesive layer when subject to in-plane tensile loading. FE modelling was performed for two distinct repair patch shapes. The first model consisted of a circular repair patch replicating typical manual scarf repair with circular layers. The second model represented an AFP produced repair patch consisting of several layers of discrete composite tows with straight-edge endings. The FE models considered a scarf repair applied to a parent structure consisting of 32 layers of AS4 3501-6 carbon/epoxy composite laminate with a taper ratio of 50:1. The repair patches consisted of an eight-layered layup matching the parent structure ply-by-ply. The parent structure was considered to be under an in-plane tensile load of 160 kN ( $\sigma = 50$  MPa). The resulting mechanical

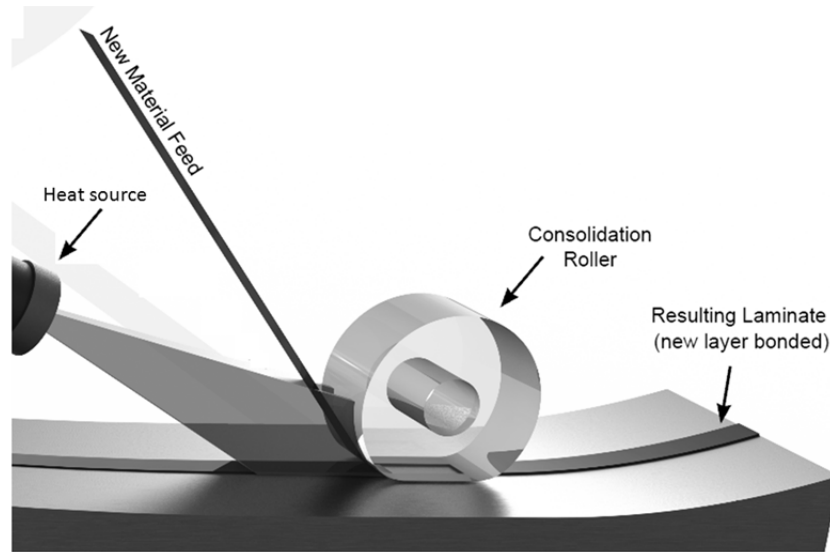
Figure 1: Automated Fibre Placement process

Automated Fibre Placement consists of placing composite prepreg strips, called tows, which have unidirectional fibers pre-impregnated with resin. The composite tow bands are collimated on the AFP composite head mounted on an industrial robot and placed on a tool or mold [13-16]. The prepreg tape is either stored on the composite head or delivered to the head from a creel cabinet. The material is then delivered to a compaction roller where additional heat and force are applied to the material before placement as shown in figure 1 (adapted from [17]). The implementation of such automated technologies is heavily influenced by the AFP equipment capabilities with key parameters including minimum cut length, turning radius, tow-drop areas and the use of either non-rotatable or rotatable cutters [18]. The robot program that controls process speed and position is developed off-line using software packages. Automated manufacturing methods such as high-speed fibre placement enhance productivity by increasing composite layup rates. Indeed, aerospace companies have claimed reductions in man hours of up to 70 – 85 %, and scrap rates reduced to 5 % instead of 25-30 % with manual layup [5].

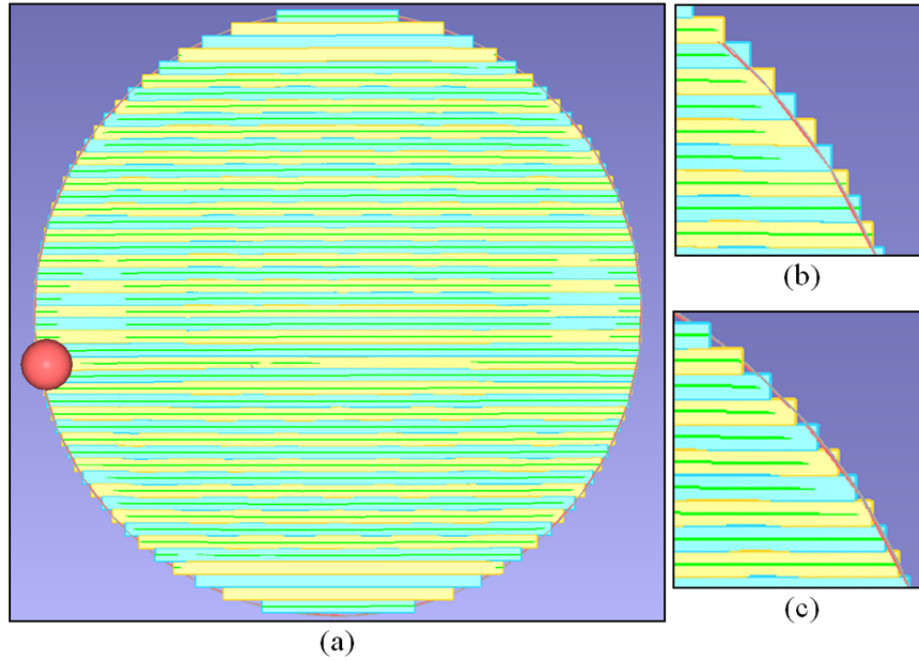
Figure 2: (a) Circular patch layup, (b) adjusted tow/boundary overall (full coverage), (c) partial tow/boundary overlap (tow meets ply boundary)

The top layer of the circular repair patch layup generated in VCP is shown in figure 2 (a). The results highlight the tow-boundary overlap as a key parameter as it dictates the tow length. Indeed, for the circular patch the tow is set to end when the ply area is fully covered by the prepreg tape which results in the tape over-extending past the ply boundary as shown in figure 2 (b). This can result in thickness build-up and overlaps which when compounded over several layers can create mismatch between the parent material and repair patch plies as well as generate stress concentration areas. If the tow is set to end when the centerline hits the ply boundary, as shown in figure 2 (c), gaps appear between the composite tape and the ply boundary which can result in both overlaps and resin-rich areas. In this study the repair patch layers were designed with no overlap of the composite tow over the ply boundary and the resulting gaps were considered to be filled with the adhesive FM300 as seen in figure 3(a). This eliminates potential material build-up or overlaps as shown in figure 3 (b).

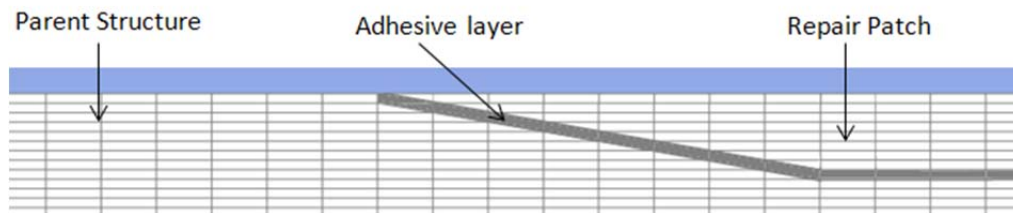
Figure 4: Adhesively bonded scarf repair patch applied to a composite panel

FE modelling and analysis of an adhesively bonded repair patch applied to a scarfed composite part was carried out using ANSYS 14.5. The parent structure consisted of 32 layers of AS4 3501-6 carbon/epoxy composite laminate with layup  $[-45/0/45/90]_{S4}$ . Each layer of carbon/epoxy was 0.2 mm thick. The length, width and thickness of the parent structure were 500 mm, 500 mm and 6.4 mm respectively. The damaged material is assumed to have been removed and the repair area scarfed with a taper ratio of 50:1. The part was repaired with a composite patch consisting of an eight-layered AS4 3501-6 carbon/epoxy composite laminate with layup  $[-45/0/45/90]_S$  matching the parent structure ply-by-ply as shown in figure 4. FM 300 adhesive with a thickness of 0.2 mm is used to bond the repair patch to the parent structure. The panel was considered to be under in-plane tensile load of 160 kN ( $\sigma = 50$  MPa) as shown in figure 5. Linear static analysis only was performed. The material properties of AS4 3501-6 carbon/epoxy material and the adhesive are shown in table 1. The model featured three main sections: the parent structure, the adhesive layer, and the repair patch. Each composite ply and the adhesive layer had one element through the thickness using layered shell elements. Face meshing was applied across each composite ply and the adhesive layer to enhance the aspect ratio and uniformity of the mesh. Also, mesh refinement across the repaired area was performed to optimize FE results. Top view of the models built for the circular patch and the AFP produced patch is shown in figure 6.

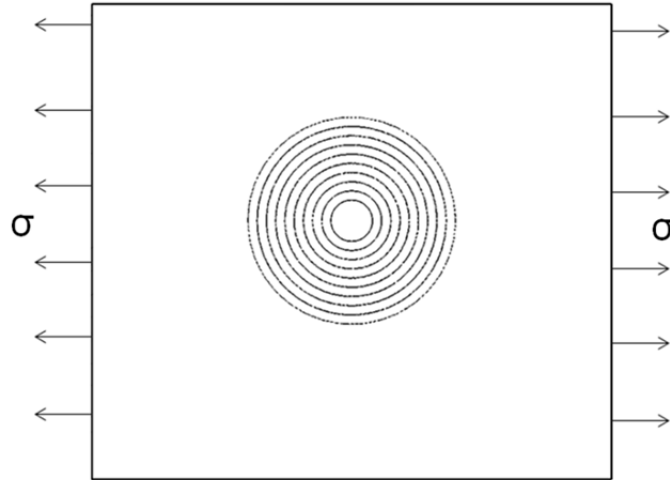
Figure 5: Panel and patch boundary and loading conditions

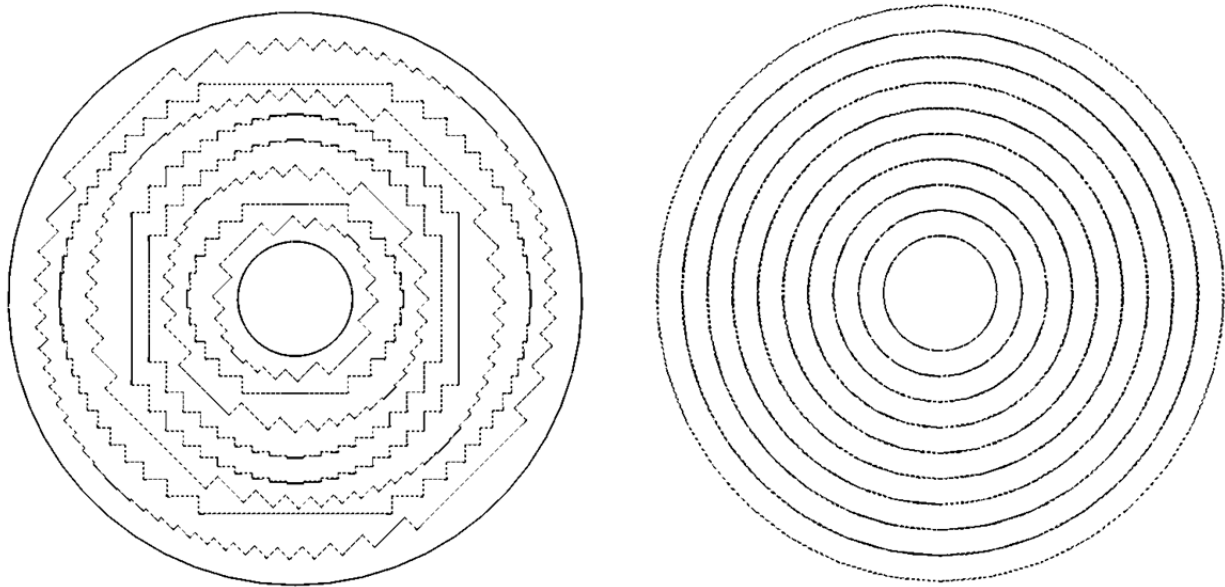
Figure 6: AFP repair patch (left) and circular repair patch (right)

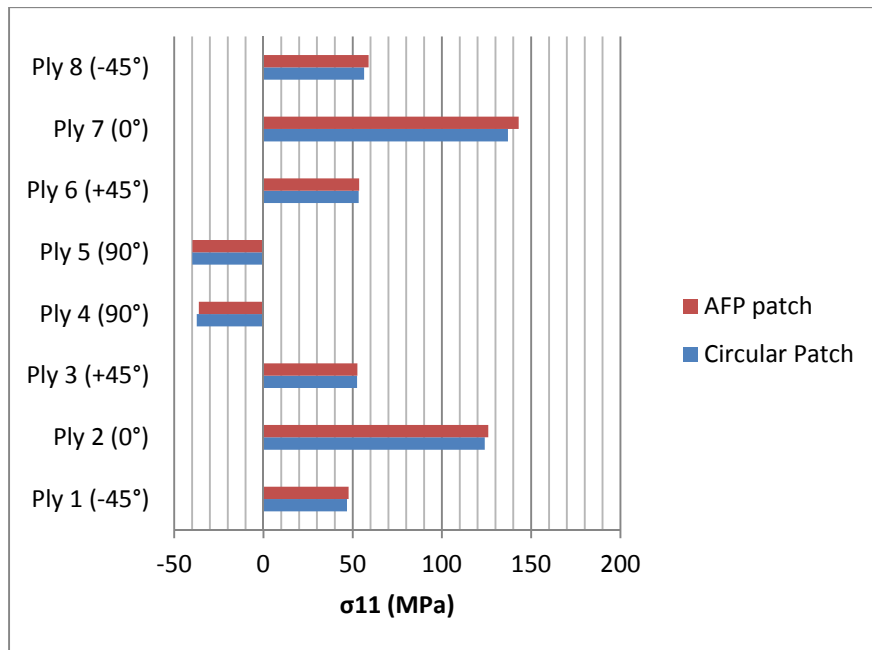
Figure 7: Stress  $\sigma_{11}$  for traditional circular patch and AFP circular patch

Figures 7, 8 and 9 show stresses  $\sigma_{11}$ ,  $\sigma_{22}$  and  $\sigma_{12}$ , respectively, for both traditional circular repair patch and AFP produced patch for each ply. Longitudinal stress values  $\sigma_{11}$  show high stress levels at layers with  $0^\circ$  fibre angle as they are in line with the loading direction and hence carry most of the load. Transverse stress values  $\sigma_{22}$  show high stress levels at layers with fibre angles at  $90^\circ$  and shear stress values  $\sigma_{12}$  show peak stress levels at  $\pm 45^\circ$  layers. The results are in line with elementary mechanics of composites principles. It can be observed that stresses  $\sigma_{11}$ ,  $\sigma_{22}$  and  $\sigma_{12}$  for the AFP produced patch are higher by up to 5 % compared to the circular repair patch. This is due to the considerable changes required in the repair patch shape to accommodate for the AFP method which resulted in a smaller surface area for the patch layers causing a higher load being carried by the AFP repair patch plies.

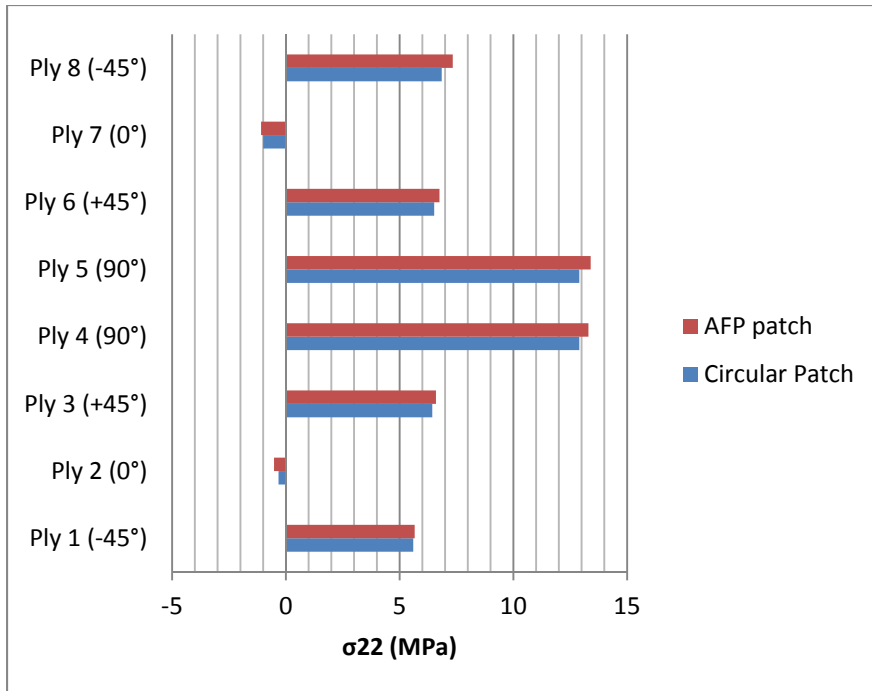
Figure 8: Stress  $\sigma_{22}$  for traditional circular patch and AFP circular patch

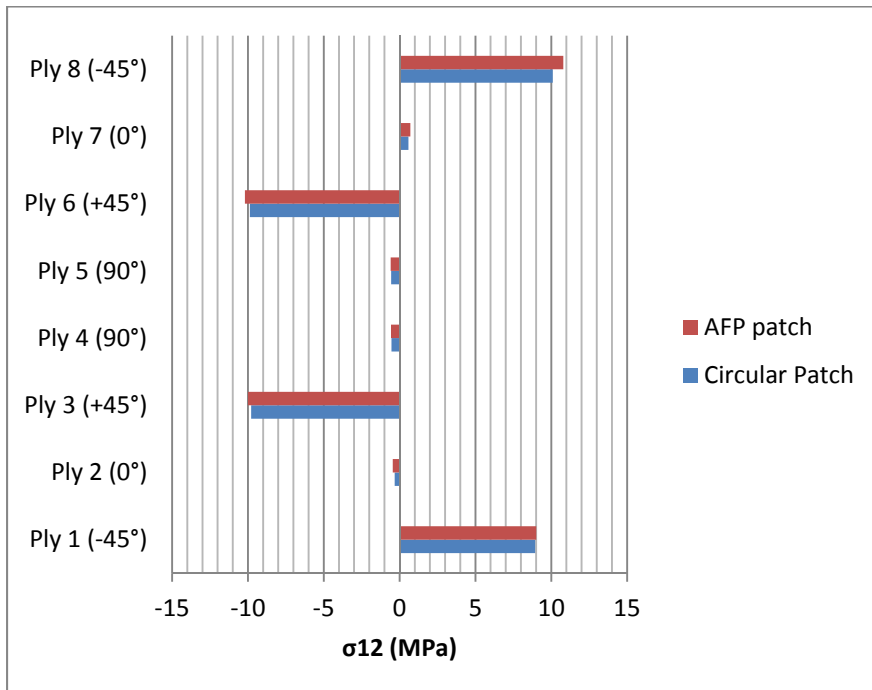
Figure 9: In-plane shear stress  $\sigma_{12}$  for traditional circular patch and AFP circular patch

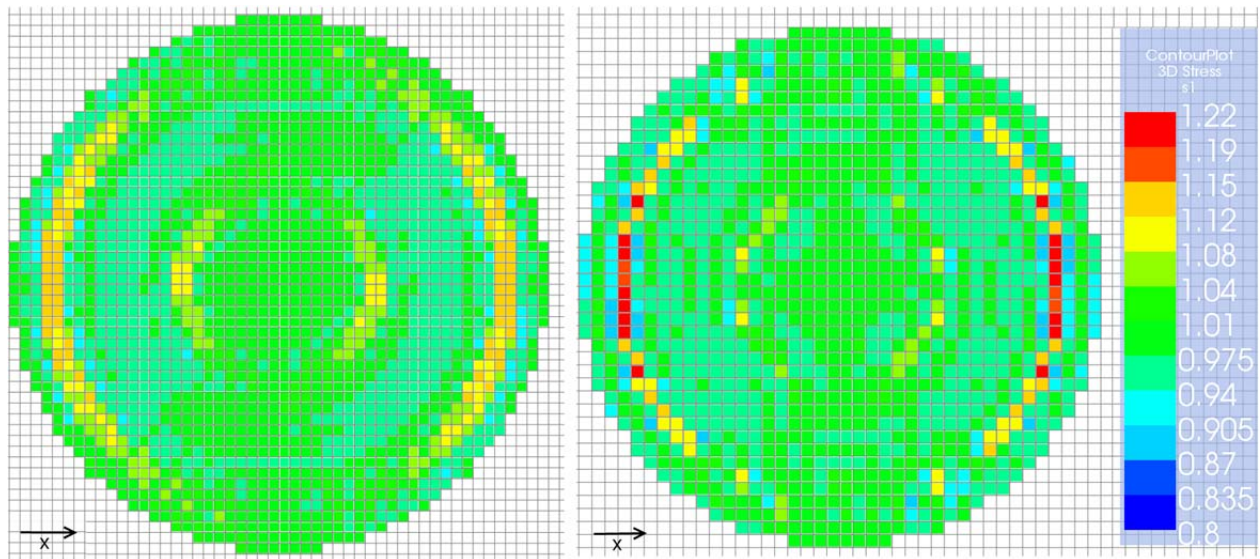
Figure 10:  $\sigma_{11}$  in the adhesive for circular repair patch (left) and AFP produced patch (right)

Figures 10, 11 and 12 show stresses  $\sigma_{11}$ ,  $\sigma_{22}$  and  $\sigma_{12}$  respectively in the adhesive layer for the circular patch and the AFP produced patch. Longitudinal stress  $\sigma_{11}$  and transverse stress values  $\sigma_{22}$  show high stress levels in the areas in line with the loading direction. Again, this agrees with elementary mechanics of composites principles. As shown in figure 10, longitudinal stress values  $\sigma_{11}$  for the AFP produced patch are higher by up to 6 % compared to the circular repair patch while transverse stress  $\sigma_{22}$  and shear stress  $\sigma_{12}$  show a significant increase by up to 26 % for the AFP produced patch as shown in figure 11 and figure 12 respectively. This may be due to the increased load transferred to the adhesive layer in the AFP produced patch. Indeed, design changes required to accommodate for the AFP method resulted in a larger volume for the adhesive layer causing the adhesive to carry more load.

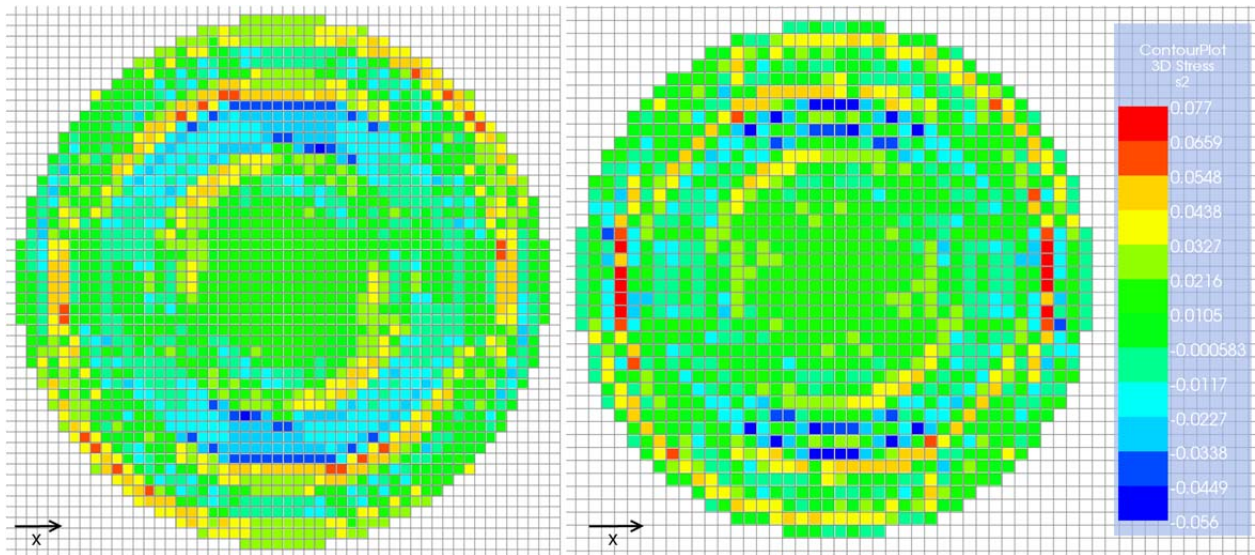
Figure 11:  $\sigma_{22}$  in the adhesive for circular repair patch (left) and AFP produced patch (right)

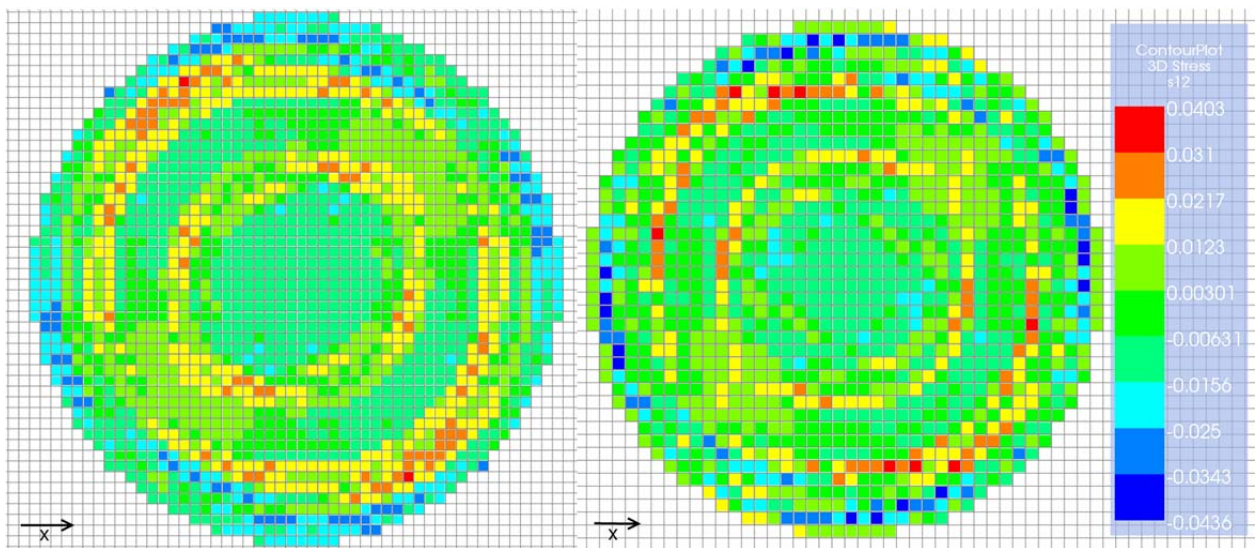
Figure 12:  $\sigma_{12}$  in the adhesive for circular repair patch (left) and AFP produced patch (right)

Furthermore, shear stress in the adhesive layer between orthotropic laminates has been shown to create highly concentrated areas at the termination points of plies oriented in the main loading direction and across the thickness due to variation in ply properties in composite laminates [5]. This is further compounded when using the AFP method as ply drop-offs become critical areas due to the straight-edge cut of composite prepreg tape which can create stress concentration at tape edges as shown in figure 14. This phenomenon is particularly acute in the top plies and can be seen for longitudinal, transverse and shear stresses with maximum values seen at the edges of the adhesive where the top composite plies meet the adhesive layer.

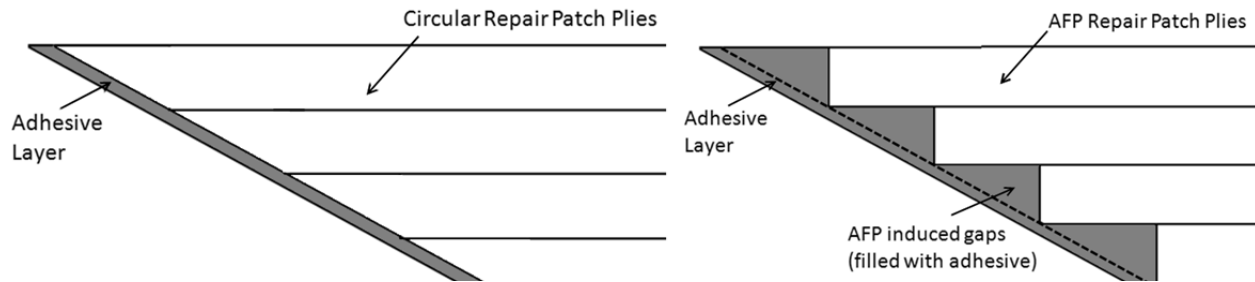
Figure 13: circular repair patch (left) and AFP repair patch layup (right)
